## Annual Inspection

Mid Suffolk District Council

Drinkstone

Annual Inspection - 03 August 2017 at 14:57 Inspector: Robert Baldock (RPII Annual Inspector)

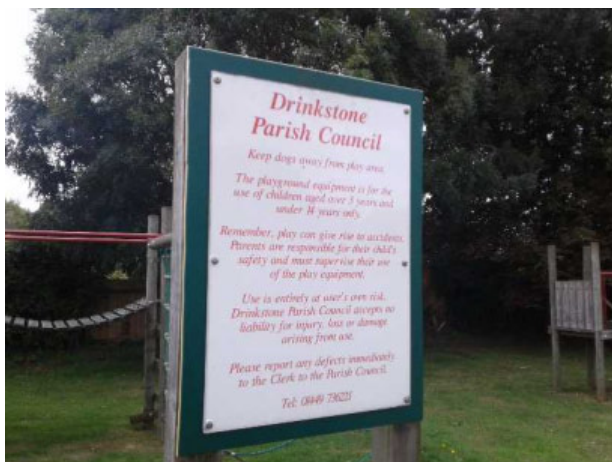
**Item:** Ancillary Items - Sign  
**Manufacturer:** Owner/Operator  
**Surface Type:** N/A  
**Equipment Compliance:** N/A  
**Surface Area Compliance:** N/A  
**Ref/Part Number:**  
**Total Findings:** 3

There is some strimmer damage apparent on the posts, this can penetrate the preservative applied to the timber and accelerate the rotting process - Monitor for any deterioration (rot) and replace as required

The item is slightly loose in its foundations - Monitor for any further deterioration and repair as required

There is some evidence of rot in the timber - Monitor for any further deterioration and replace as required

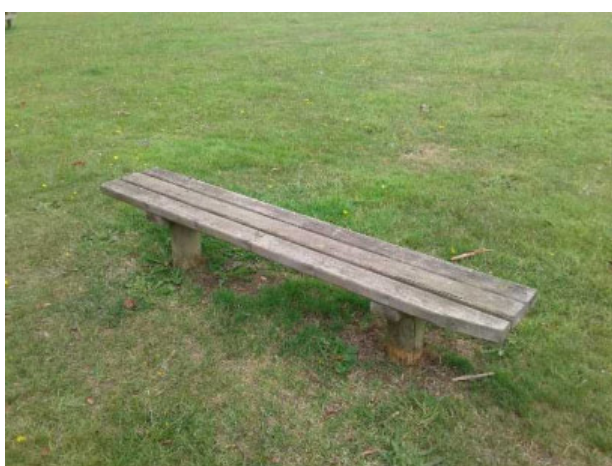
**Item:** Ancillary Items - Bench  
**Manufacturer:** Owner/Operator  
**Surface Type:** N/A  
**Equipment Compliance:** N/A  
**Surface Area Compliance:** N/A  
**Ref/Part Number:**  
**Total Findings:** 1

There is some strimmer damage apparent on the posts, this can penetrate the preservative applied to the timber and accelerate the rotting process - Monitor for any deterioration (rot) and replace as required

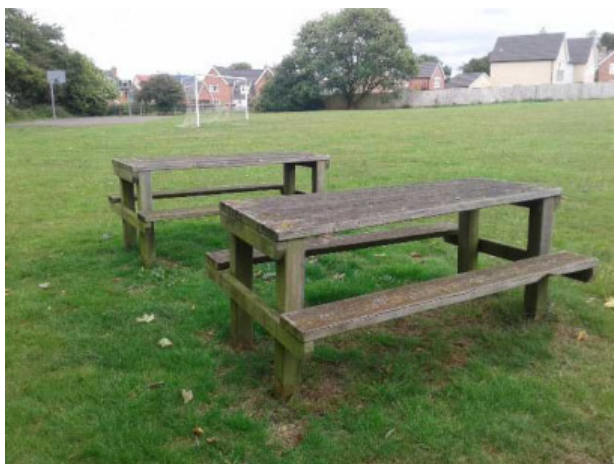
**Item:** Ancillary Items - Picnic Table  
**Manufacturer:** Owner/Operator  
**Surface Type:** N/A  
**Equipment Compliance:** N/A  
**Surface Area Compliance:** N/A  
**Ref/Part Number:**  
**Total Findings:** 2

There is some strimmer damage apparent on the posts, this can penetrate the preservative applied to the timber and accelerate the rotting process - Monitor for any deterioration (rot) and replace as required

The item is slightly loose in its foundations - Monitor for any further deterioration and repair as required

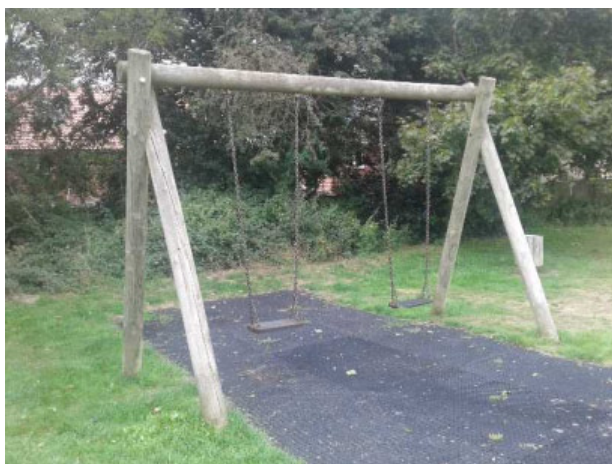
**Item:** Swings - 1 Bay 2 Seat (Flat)  
**Manufacturer:** Adventure Playgrounds  
**Surface Type:** Grass Matrix Tiles  
**Equipment Compliance:** No  
**Surface Area Compliance:** Yes  
**Ref/Part Number:**  
**Total Findings:** 6

The timber has a number of air cracks apparent, the splits will have penetrated the preservative applied to the timber and allow water ingress to the unprotected areas - Monitor for any deterioration (rot) and replace as required

There is some strimmer damage apparent on the posts, this can penetrate the preservative applied to the timber and accelerate the rotting process - Monitor for any deterioration (rot) and replace as required

There is some notable evidence of chain wear - Monitor for any further deterioration and replace when 40% worn

The bushes are showing signs of wear - Monitor for any further deterioration and replace as required

The chain openings are in excess of the 8.6mm as recommended by BS EN 1176 - Monitor use

The seat is severely damaged and requires replacing - Replace damaged seat

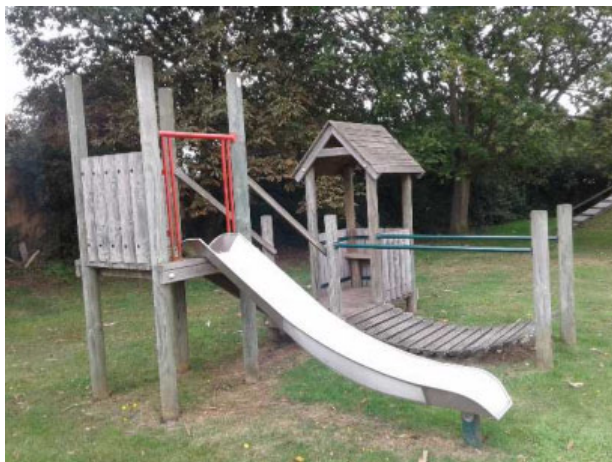
**Item:** Activity Equipment - Multi Play (Junior)  
**Manufacturer:** Adventure Playgrounds  
**Surface Type:** Grass Matrix Tiles  
**Equipment Compliance:** No  
**Surface Area Compliance:** Yes  
**Ref/Part Number:**  
**Total Findings:** 5

There is some strimmer damage apparent on the posts, this can penetrate the preservative applied to the timber and accelerate the rotting process - Monitor for any deterioration (rot) and replace as required

There is algae or moss on the surface of the equipment - Clean and treat appropriately

There is some evidence of rot in the timber - Monitor for any further deterioration and replace as required

There is/are finger entrapment/s in the top of the slide and the item fails to meet the requirements of BS EN 1176:2008 Part 1 4.2.7.6 Entrapment of fingers - Monitor use

The unit is easily accessible and should have the appropriate barriers installed as the height of the unit exceeds 600mm - Monitor use

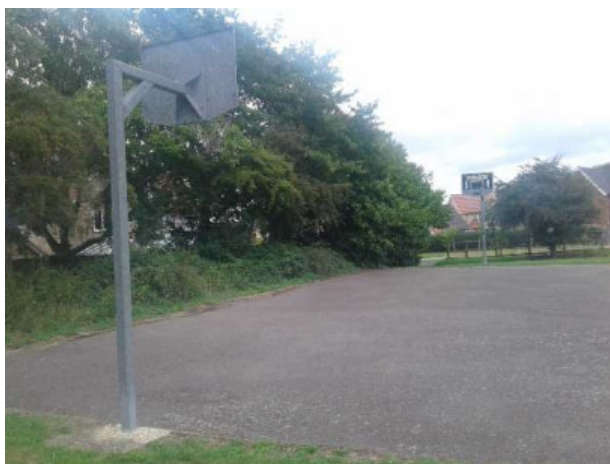
**Item:** Multi Use Games Area - Multi Use Games Area (MUGA)  
**Manufacturer:** Sport England  
**Surface Type:** Tarmac  
**Equipment Compliance:** Yes  
**Surface Area Compliance:** N/A  
**Ref/Part Number:**  
**Total Findings:** 1

The backboard is damaged - Monitor for any further deterioration and repair as required

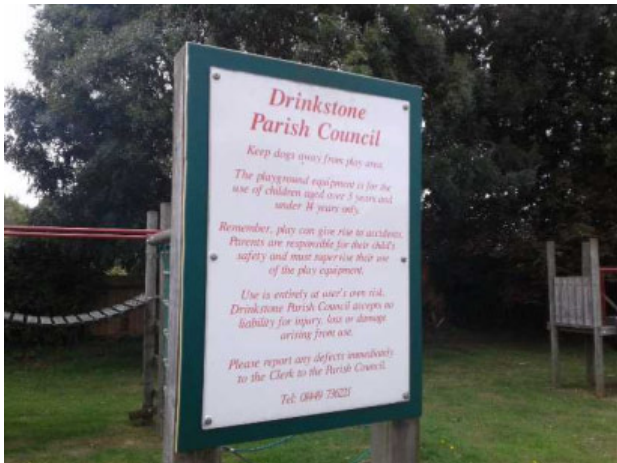
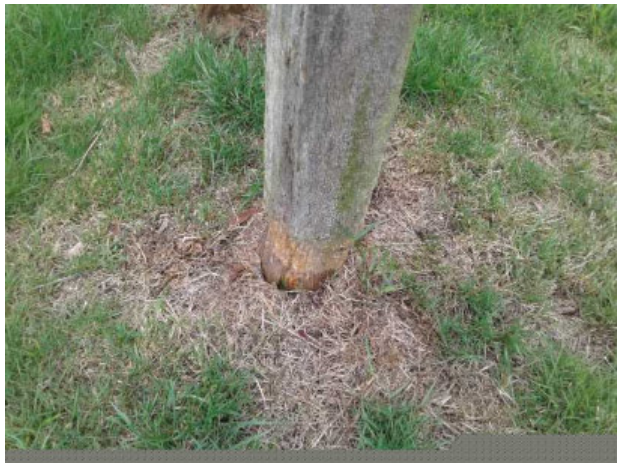
i
**6 - Low Risk (Finding 1)**

**Finding:** There is some strimmer damage apparent on the posts, this can penetrate the preservative applied to the timber and accelerate the rotting process

**Action:** Monitor for any deterioration (rot) and replace as required

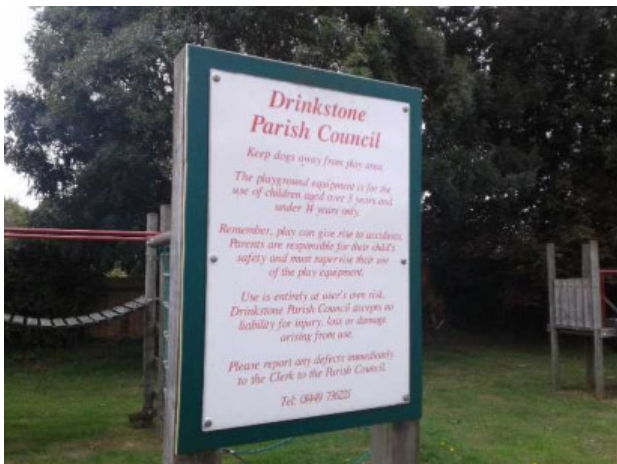
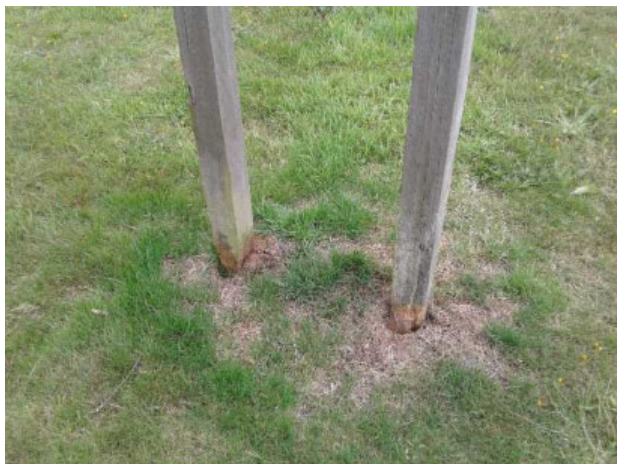
i
**6 - Low Risk (Finding 2)**

**Finding:** The item is slightly loose in its foundations

**Action:** Monitor for any further deterioration and repair as required

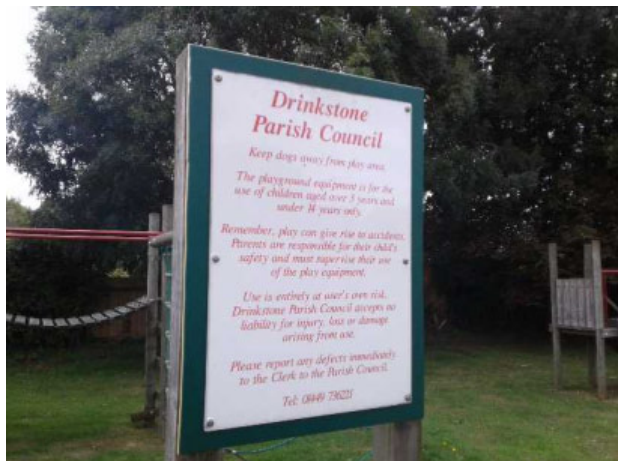
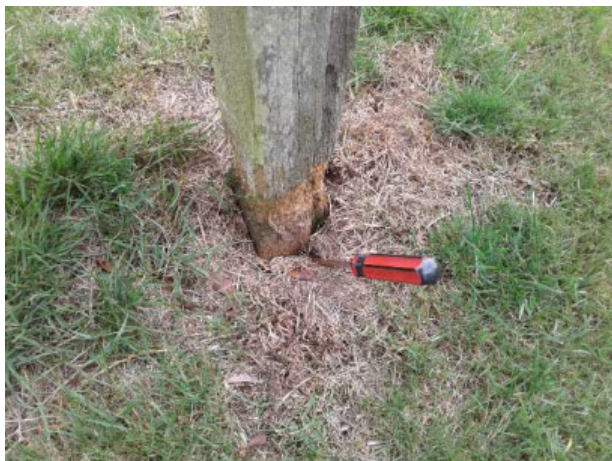
## 6 - Low Risk (Finding 3)

**Finding:** There is some evidence of rot in the timber

**Action:** Monitor for any further deterioration and replace as required

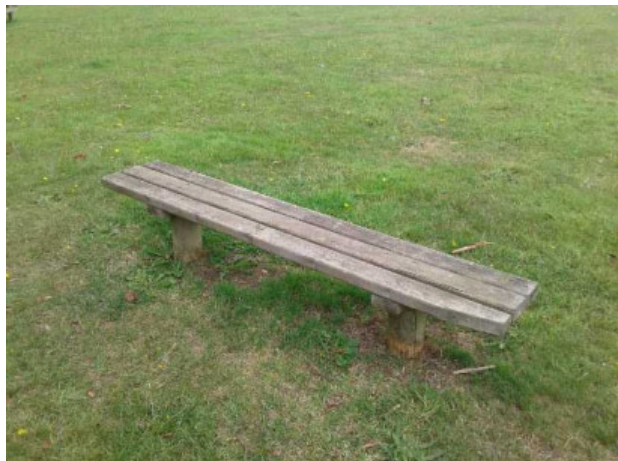
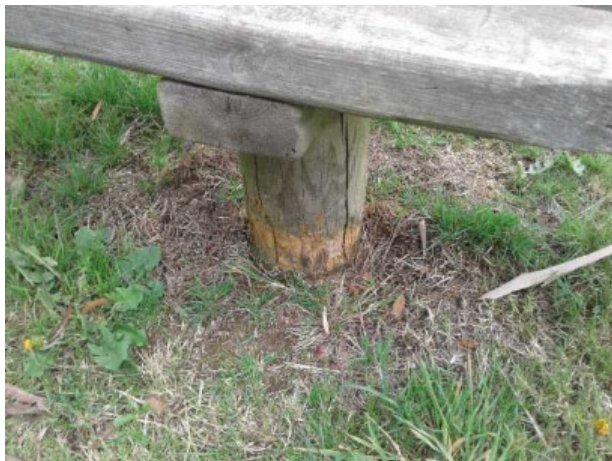
## 6 - Low Risk (Finding 1)

**Finding:** There is some strimmer damage apparent on the posts, this can penetrate the preservative applied to the timber and accelerate the rotting process

**Action:** Monitor for any deterioration (rot) and replace as required

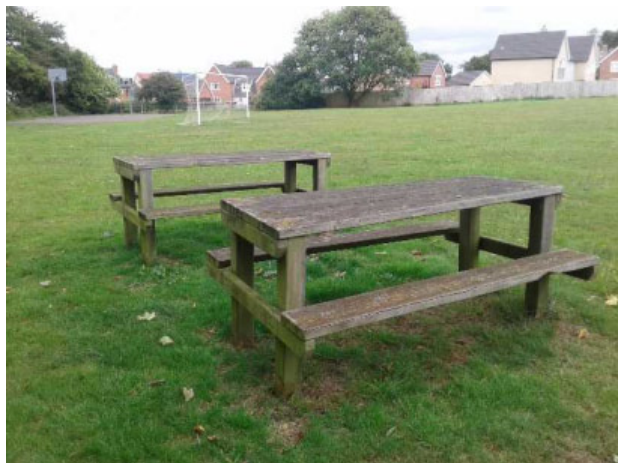
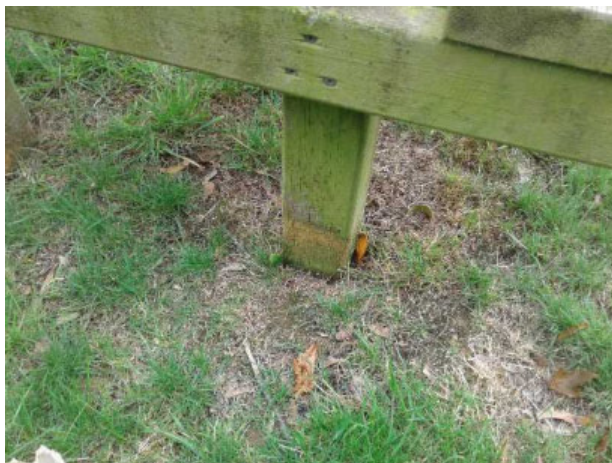
## 6 - Low Risk (Finding 1)

**Finding:** There is some strimmer damage apparent on the posts, this can penetrate the preservative applied to the timber and accelerate the rotting process

**Action:** Monitor for any deterioration (rot) and replace as required

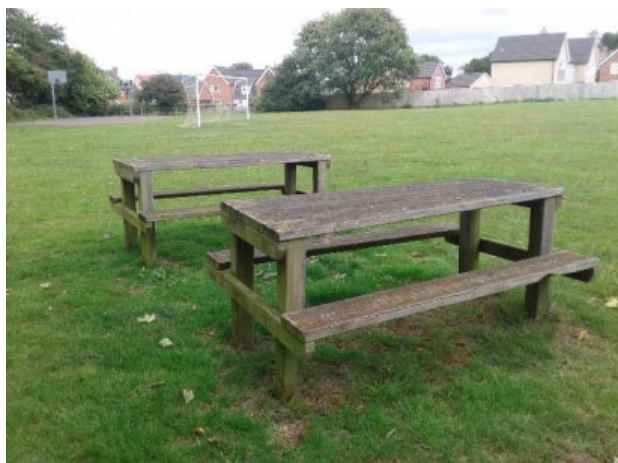
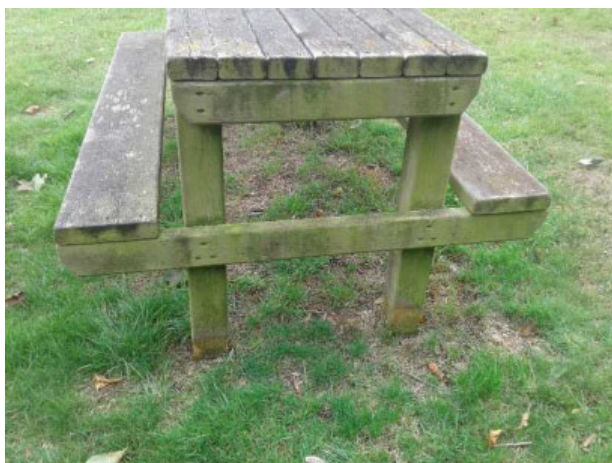
## 6 - Low Risk (Finding 2)

**Finding:** The item is slightly loose in its foundations

**Action:** Monitor for any further deterioration and repair as required

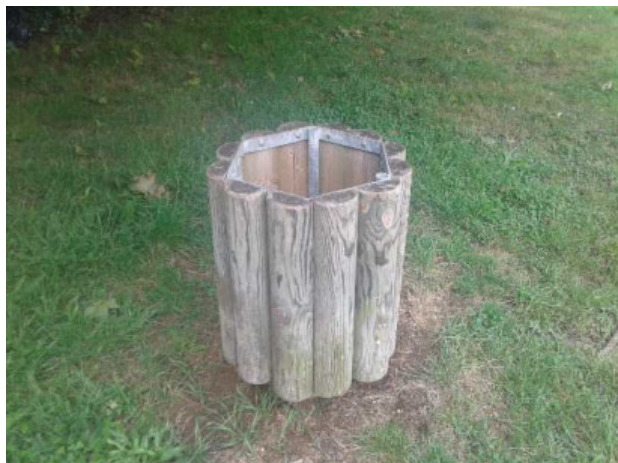
## 2 - Very Low Risk (Finding 1)

**Finding:** There is no liner present in the litterbin

**Action:** Provide as required

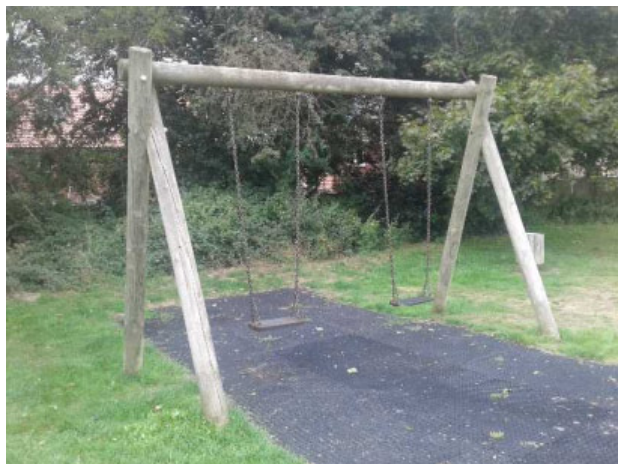
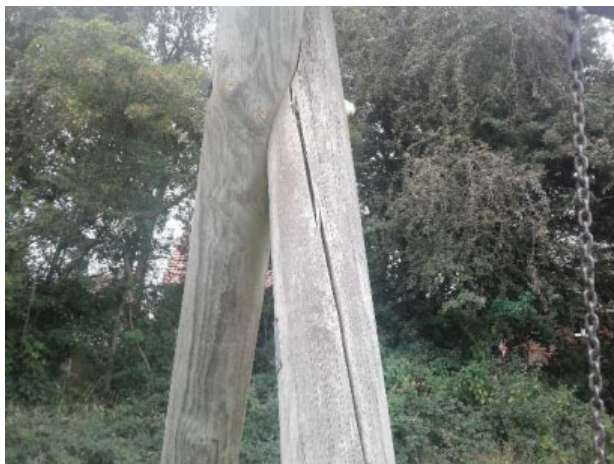
## 6 - Low Risk (Finding 1)

**Finding:** The timber has a number of air cracks apparent, the splits will have penetrated the preservative applied to the timber and allow water ingress to the unprotected areas

**Action:** Monitor for any deterioration (rot) and replace as required

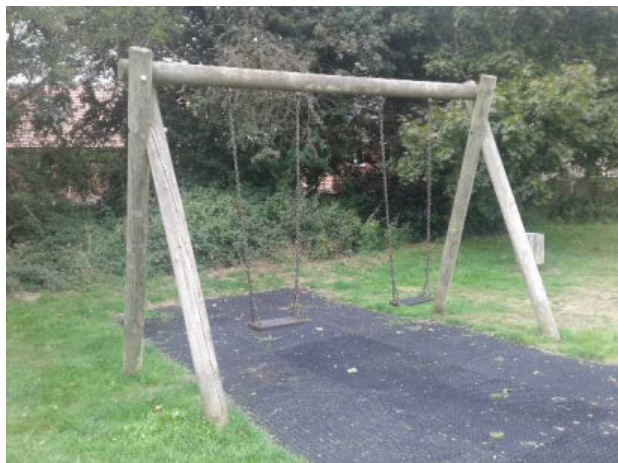
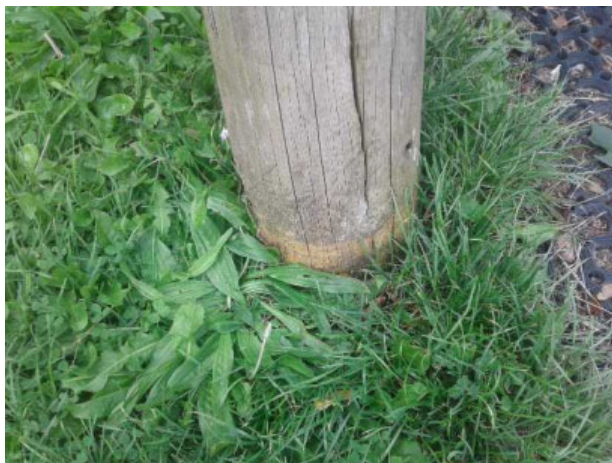
## 6 - Low Risk (Finding 2)

**Finding:** There is some strimmer damage apparent on the posts, this can penetrate the preservative applied to the timber and accelerate the rotting process

**Action:** Monitor for any deterioration (rot) and replace as required

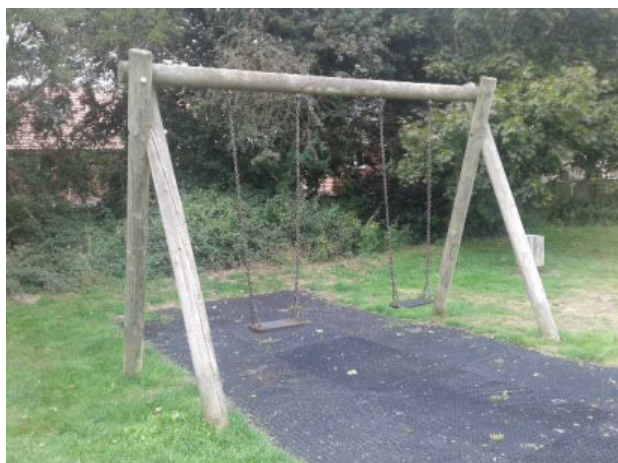
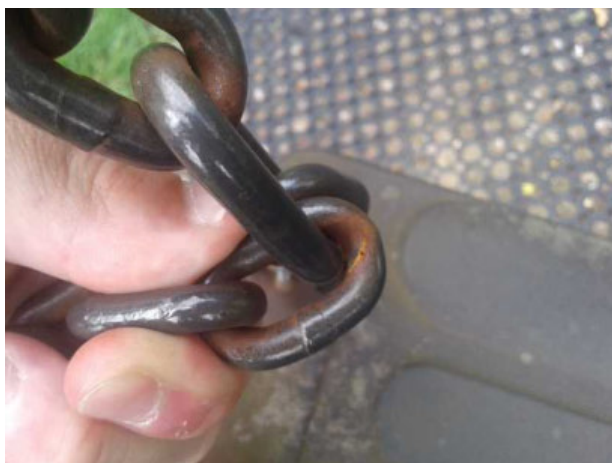
## 6 - Low Risk (Finding 3)

**Finding:** There is some notable evidence of chain wear

**Action:** Monitor for any further deterioration and replace when 40% worn

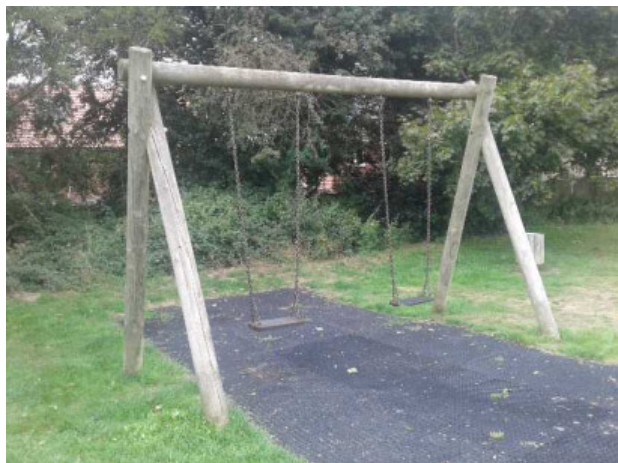
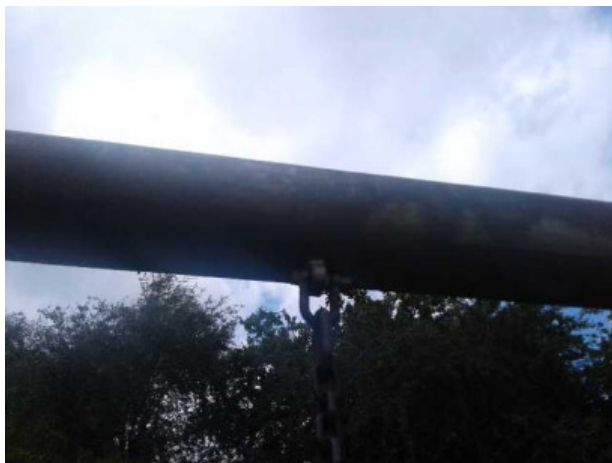
#### 4 - Very Low Risk (Finding 4)

**Finding:** The bushes are showing signs of wear

**Action:** Monitor for any further deterioration and replace as required

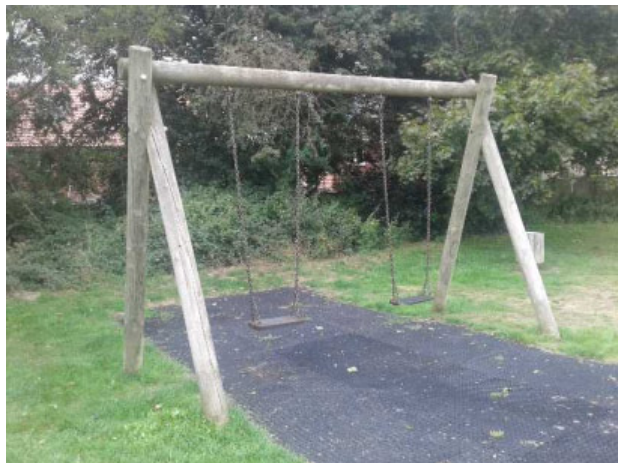
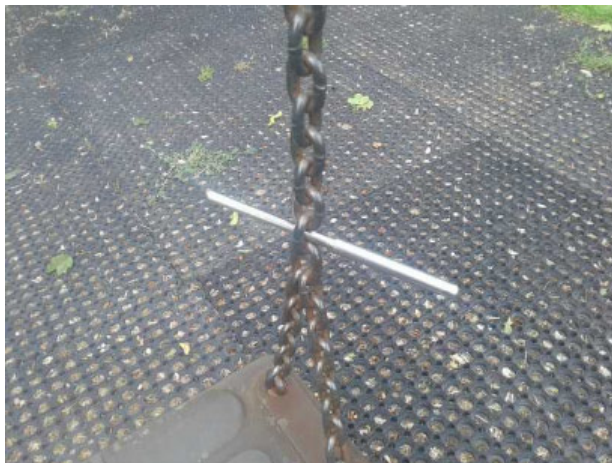
#### 5 - Very Low Risk (Finding 5)

**Finding:** The chain openings are in excess of the 8.6mm as recommended by BS EN 1176

**Action:** Monitor use

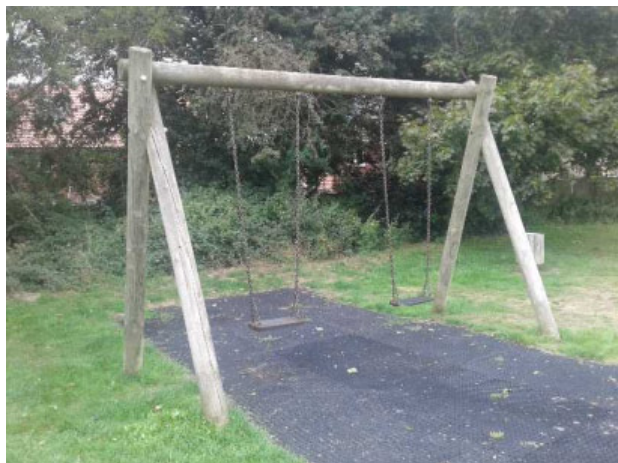
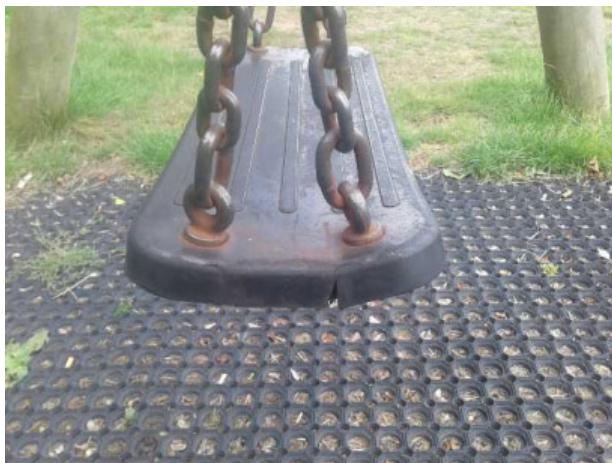
## 10 - Low Risk (Finding 6)

**Finding:** The seat is severely damaged and requires replacing

**Action:** Replace damaged seat

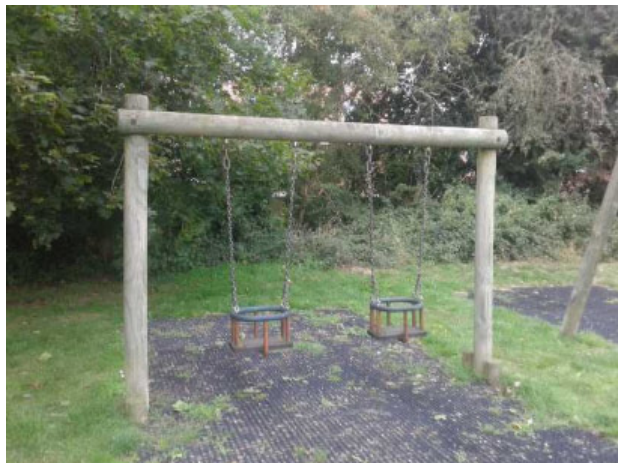
## 6 - Low Risk (Finding 1)

**Finding:** The tree canopy overhangs the equipment and is less than 2.0m away

**Action:** Lift tree canopy to ensure a minimum clearance of 2.0m from the equipment

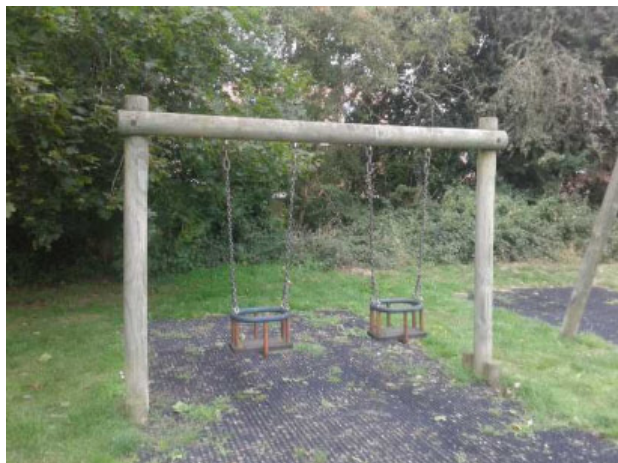
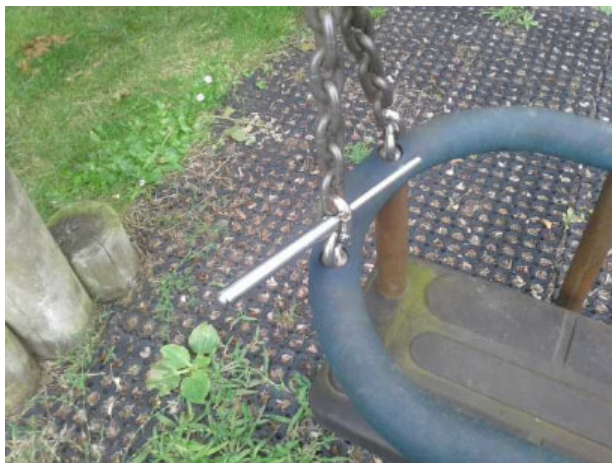
#### 5 - Very Low Risk (Finding 2)

**Finding:** The connecting links are in excess of 8.6mm and less than 12mm and fail the requirements of BS EN 1176: 2008 Part 1; clause 4.2.13, Chains

**Action:** Monitor use

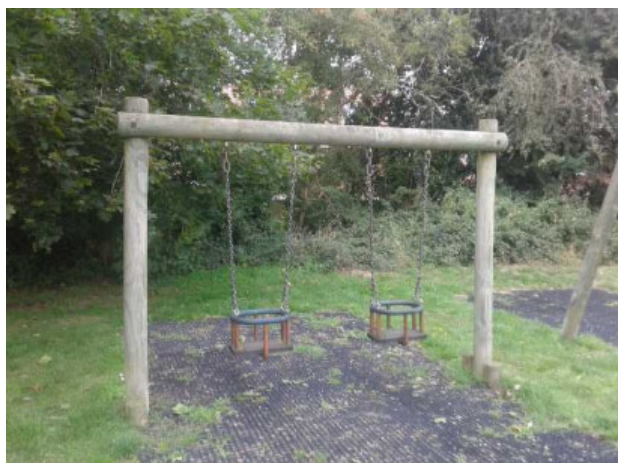
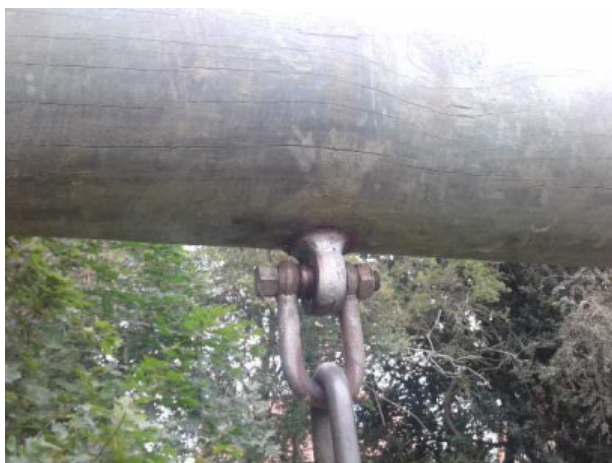
#### 4 - Very Low Risk (Finding 3)

**Finding:** The bushes are showing signs of wear

**Action:** Monitor for any further deterioration and replace as required

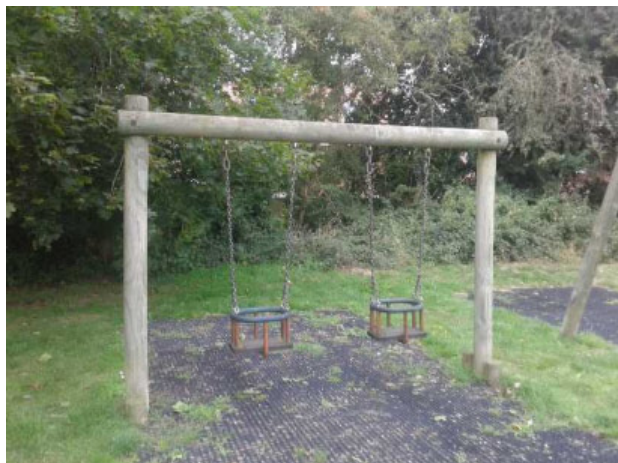
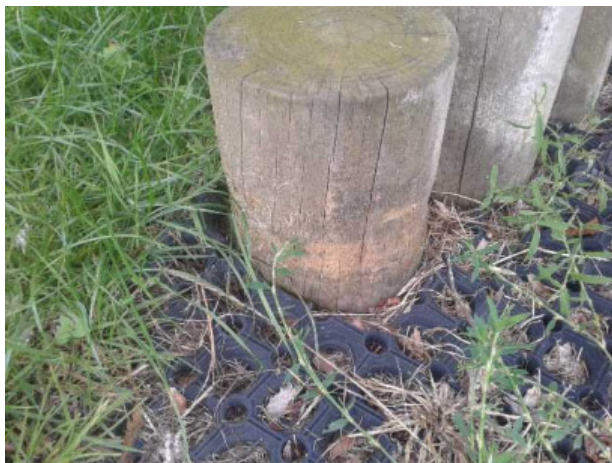
## 6 - Low Risk (Finding 4)

**Finding:** There is some strimmer damage apparent on the posts, this can penetrate the preservative applied to the timber and accelerate the rotting process

**Action:** Monitor for any deterioration (rot) and replace as required

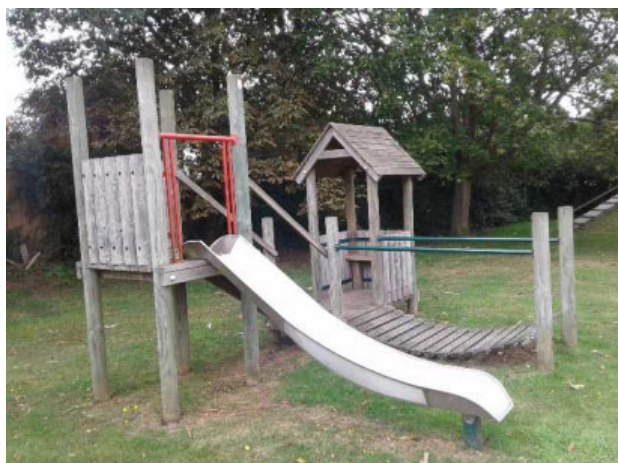
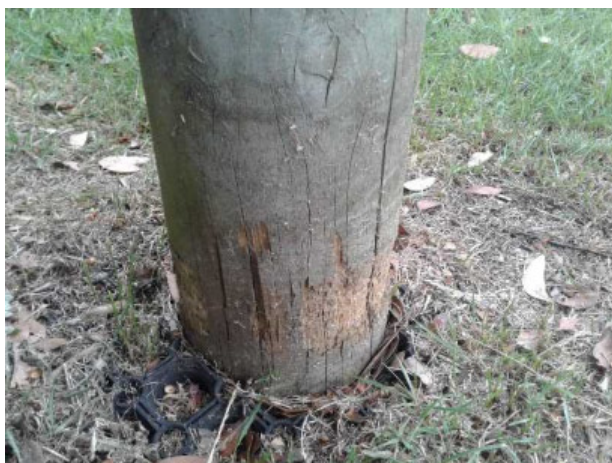
## 6 - Low Risk (Finding 1)

**Finding:** There is some strimmer damage apparent on the posts, this can penetrate the preservative applied to the timber and accelerate the rotting process

**Action:** Monitor for any deterioration (rot) and replace as required

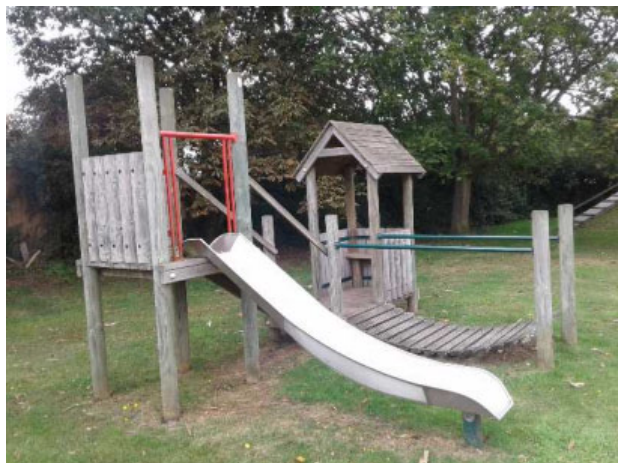
## 8 - Low Risk (Finding 2)

**Finding:** There is algae or moss on the surface of the equipment

**Action:** Clean and treat appropriately

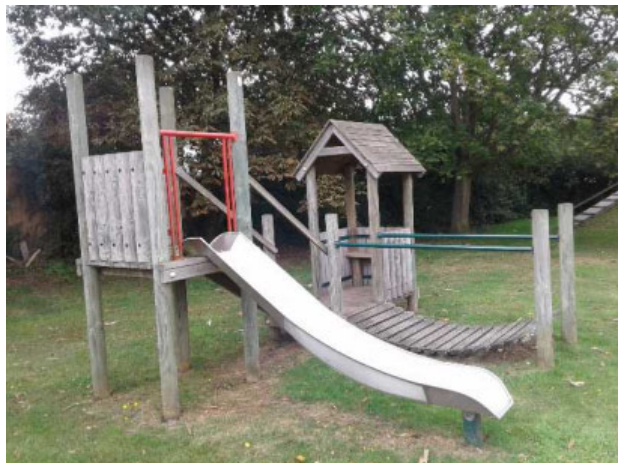
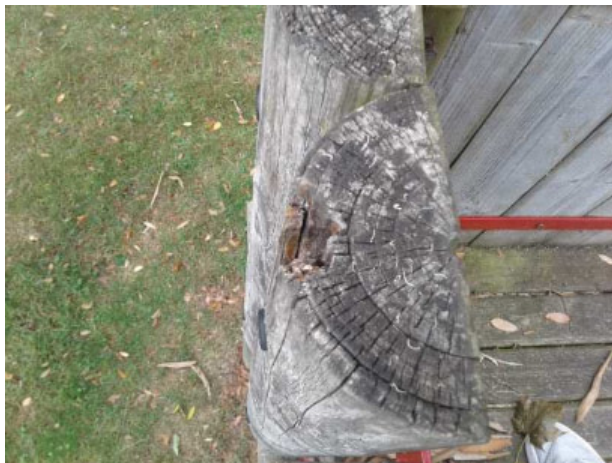
## 6 - Low Risk (Finding 3)

**Finding:** There is some evidence of rot in the timber

**Action:** Monitor for any further deterioration and replace as required

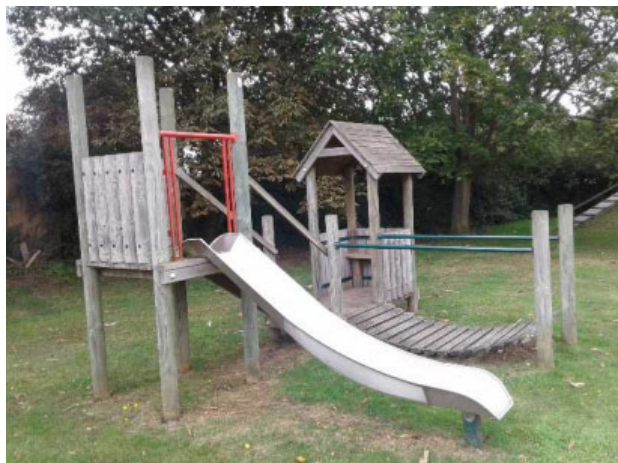
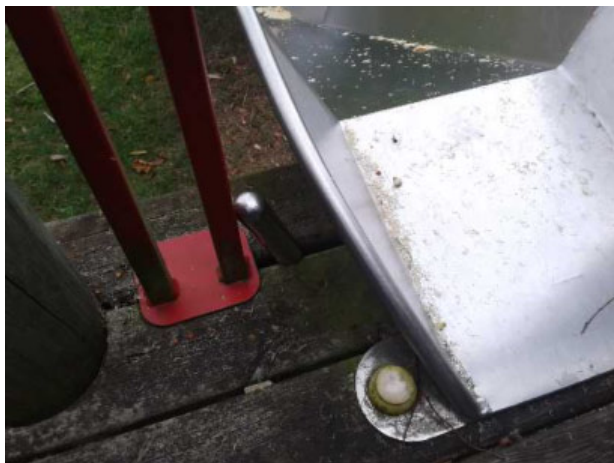
#### 5 - Very Low Risk (Finding 4)

**Finding:** There is/are finger entrapment/s in the top of the slide and the item fails to meet the requirements of BS EN 1176:2008 Part 1 4.2.7.6 Entrapment of fingers

**Action:** Monitor use

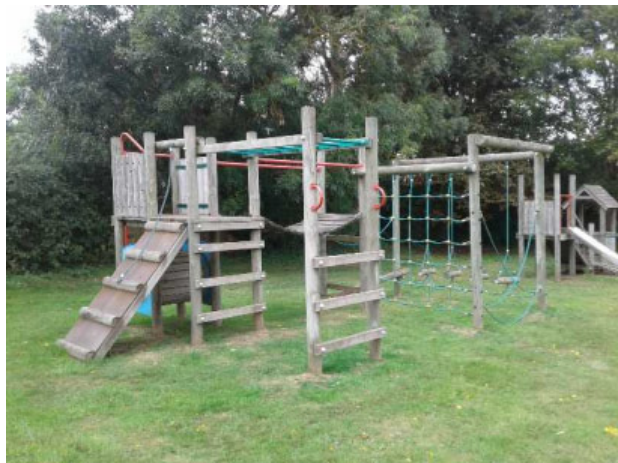
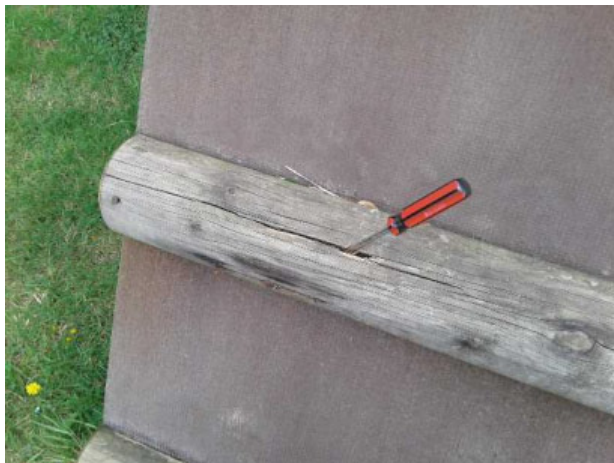
## 8 - Low Risk (Finding 2)

**Finding:** There are areas or parts of the timber on the structure that have rotted

**Action:** Replace all affected timbers

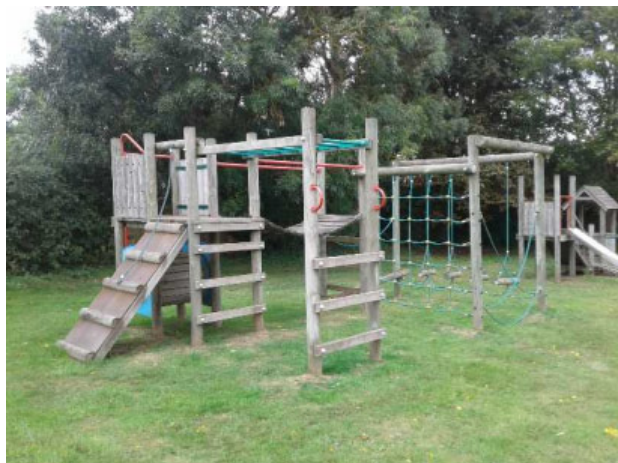
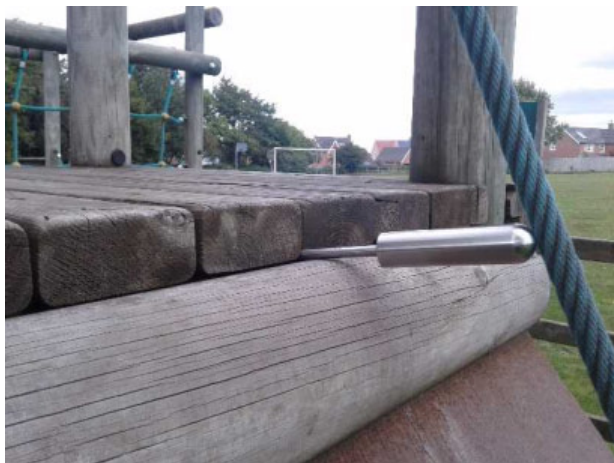
### 5 - Very Low Risk (Finding 3)

**Finding:** There is/are finger entrapment/s in the top of the ramp and the item fails to meet the requirements of BS EN 1176:2008 Part 1 4.2.7.6 Entrapment of fingers

**Action:** Monitor use

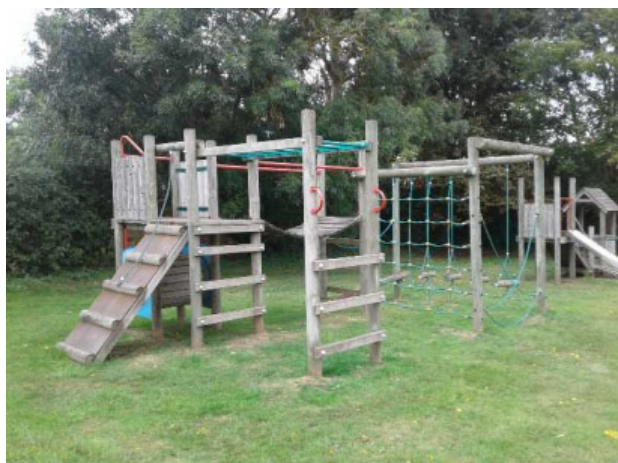
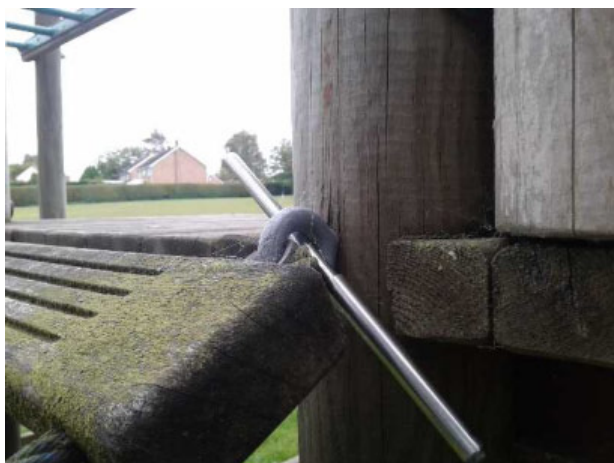
### 5 - Very Low Risk (Finding 4)

**Finding:** The connecting links are in excess of 8.6mm and less than 12mm and fail the requirements of BS EN 1176: 2008 Part 1; clause 4.2.13, Chains

**Action:** Monitor use

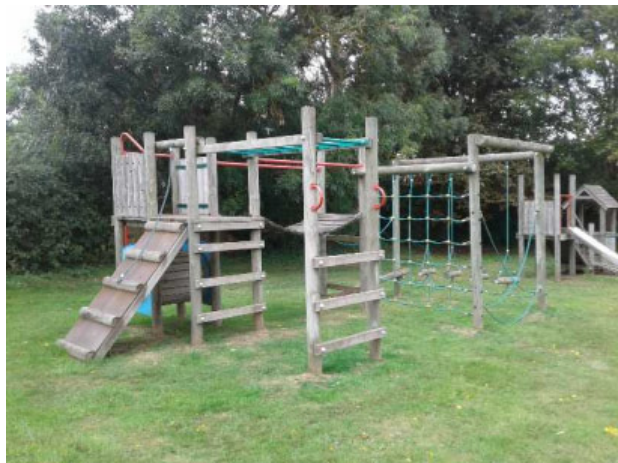
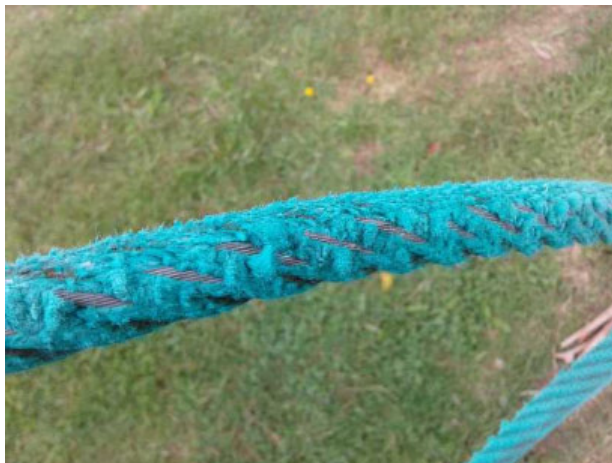
## 6 - Low Risk (Finding 6)

**Finding:** The ropes/nets are worn/damaged in places

**Action:** Monitor for any further deterioration and repair or replace as required

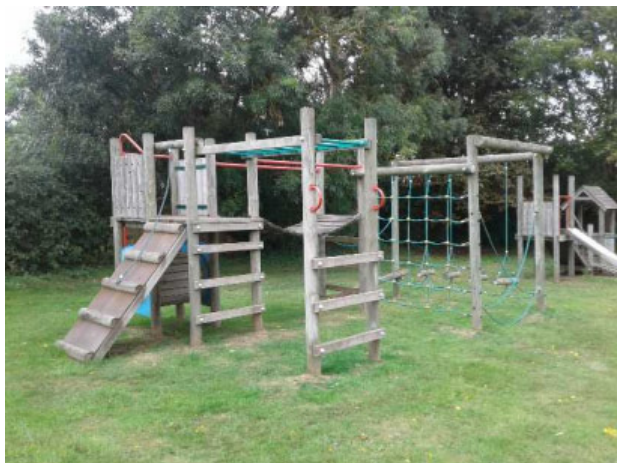
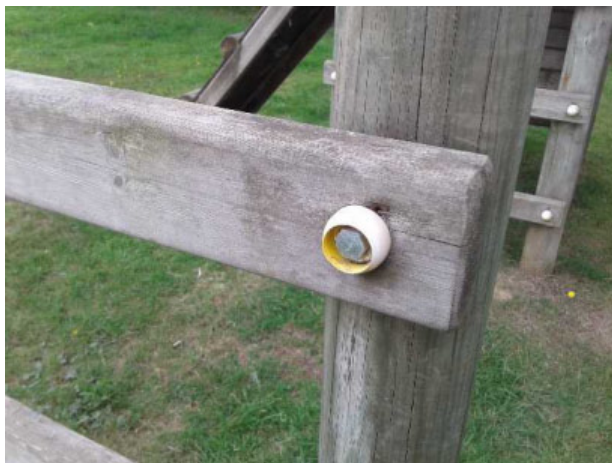
**Finding:** There is/are bolt cap covers missing or damaged on the item

**Action:** Replace missing or damaged bolt cap covers

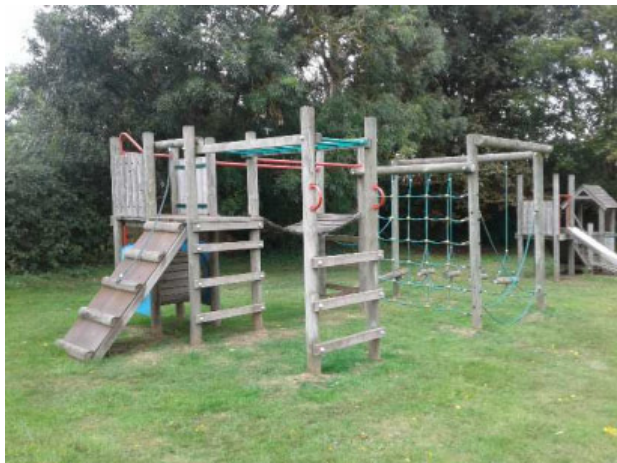
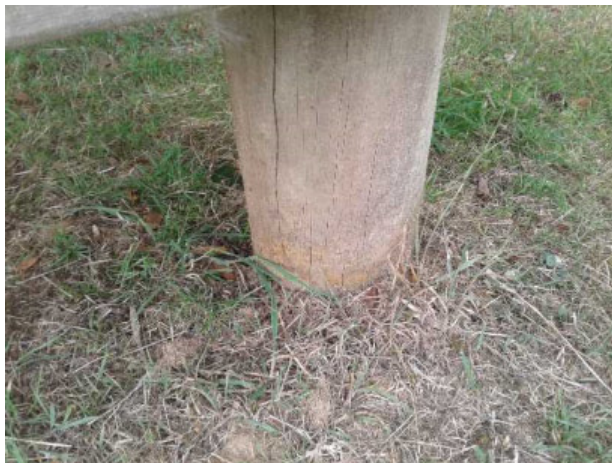
**Finding:** There is some strimmer damage apparent on the posts, this can penetrate the preservative applied to the timber and accelerate the rotting process

**Action:** Monitor for any deterioration (rot) and replace as required

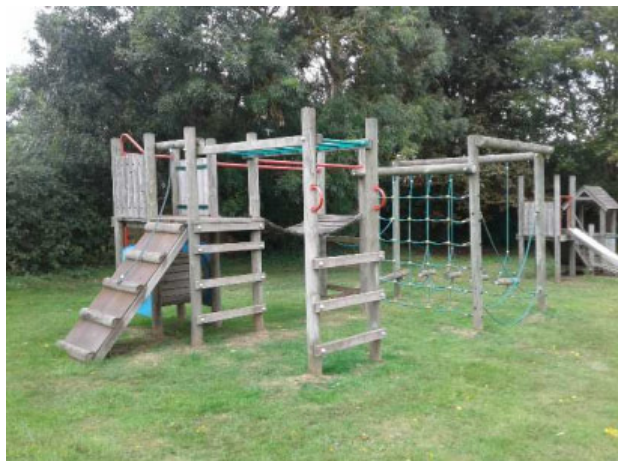
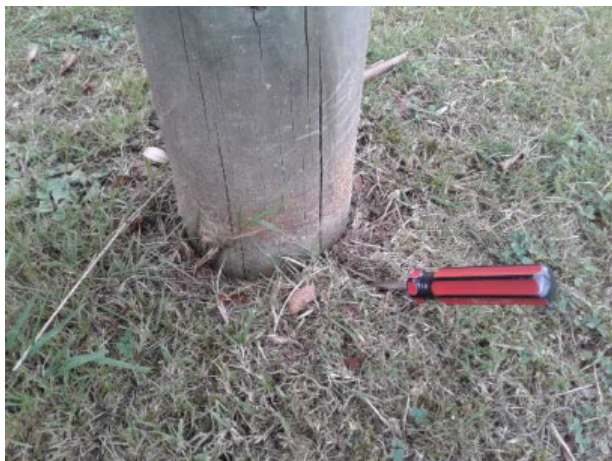
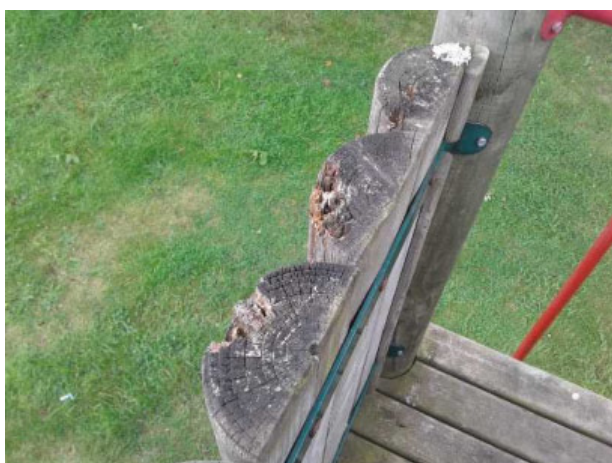
**Finding:** There is some evidence of rot in the timber

**Action:** Monitor for any further deterioration and replace as required

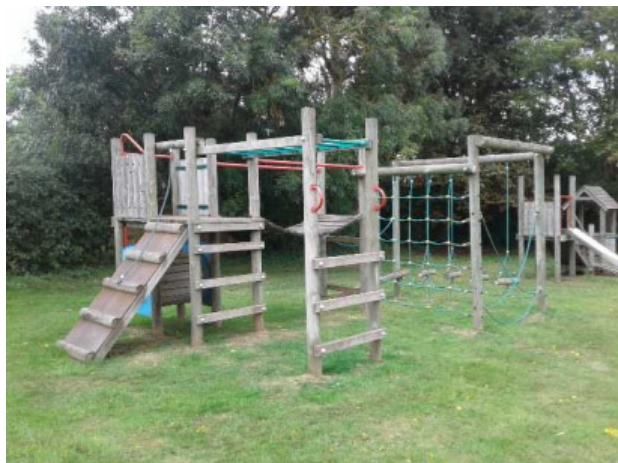
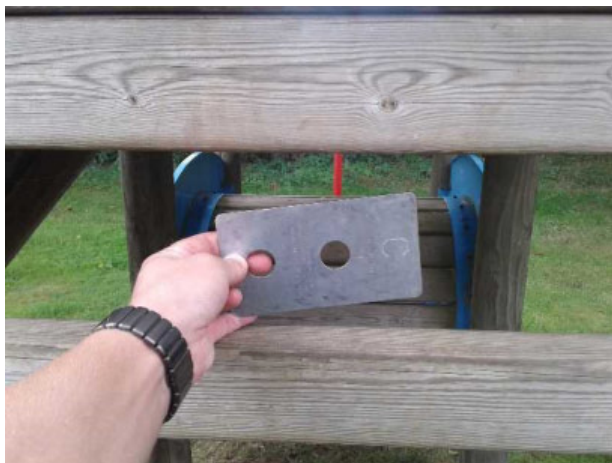
**Finding:** The item fails to meet the requirements of BS EN 1176:2008 Part 1 4.2.7.2 head and neck entrapment in the barriers and/or steps

**Action:** Monitor use

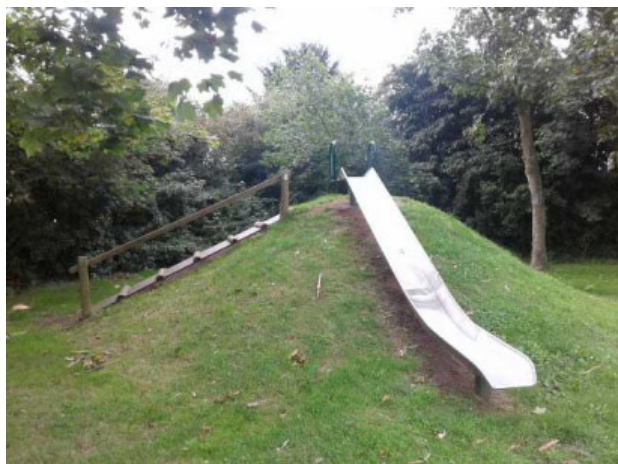
**Finding:** The surface has eroded in some areas

**Action:** Reinstate the surface

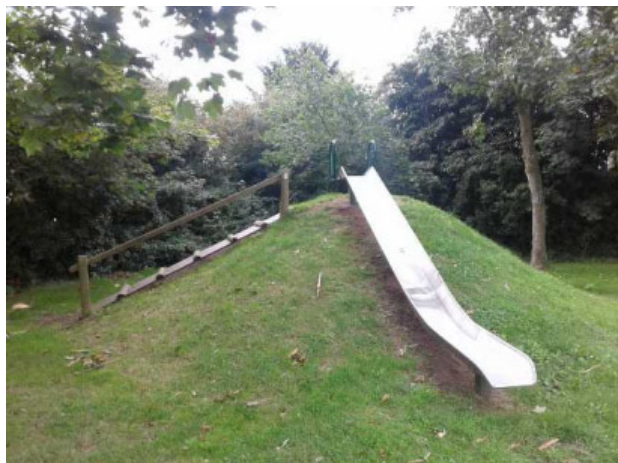
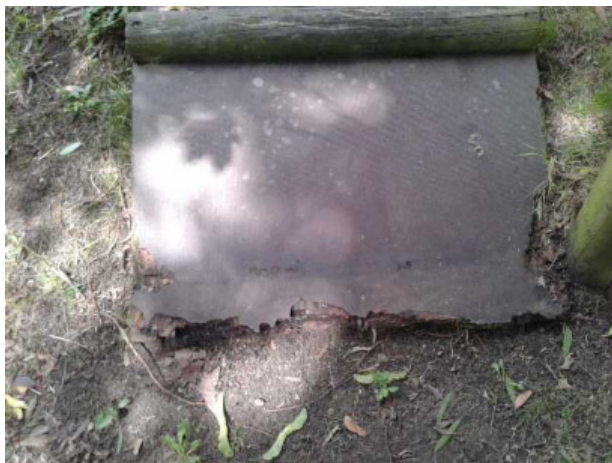
**Finding:** There are areas or parts of the timber on the structure that have rotted **Action:** Replace all affected timbers

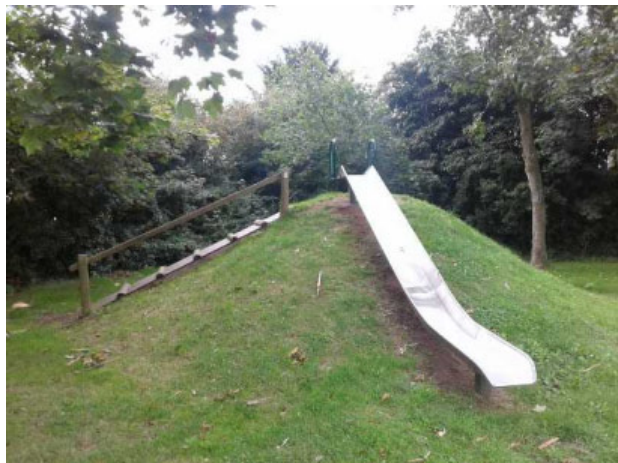
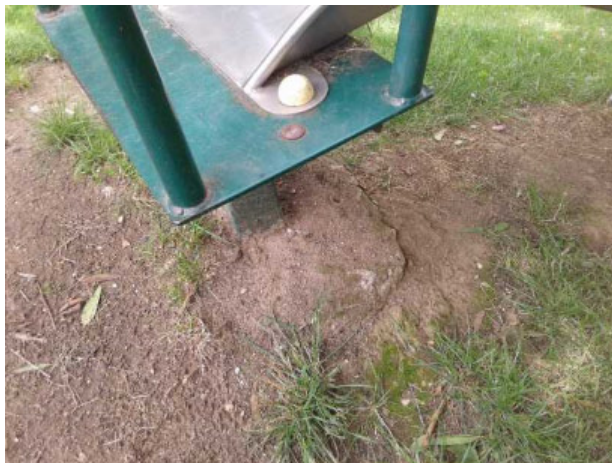
**Finding:** The surface has eroded and the foundations are exposed **Action:** Reinstall surrounding surfaces to cover the foundations

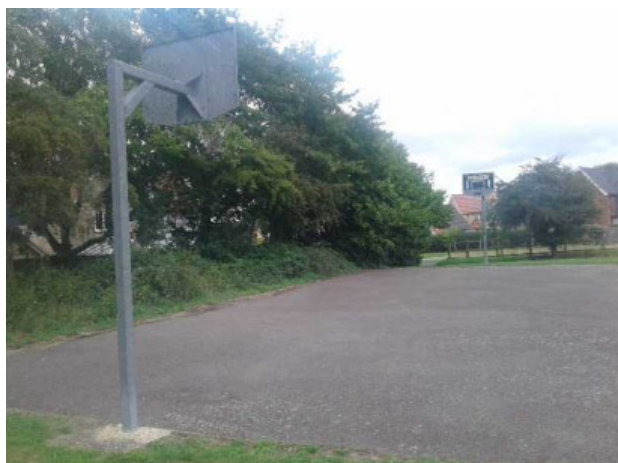
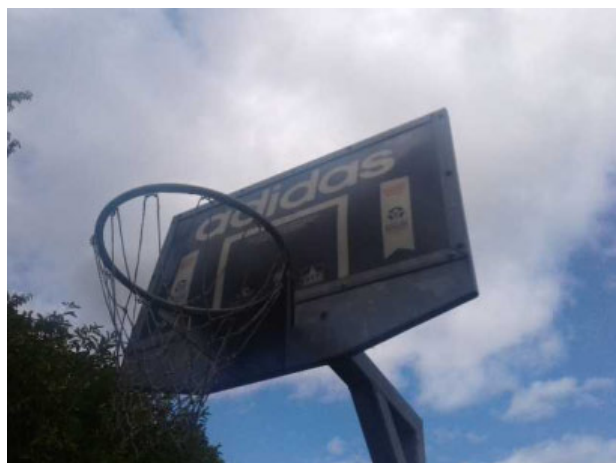
**Finding:** The backboard is damaged

**Action:** Monitor for any further deterioration and repair as required
