## Annual Inspection

Mid Suffolk District Council

Drinkstone

Inspected: 12-August-2021 - 06:00 by Lyn Williams RPII Annual Inspector

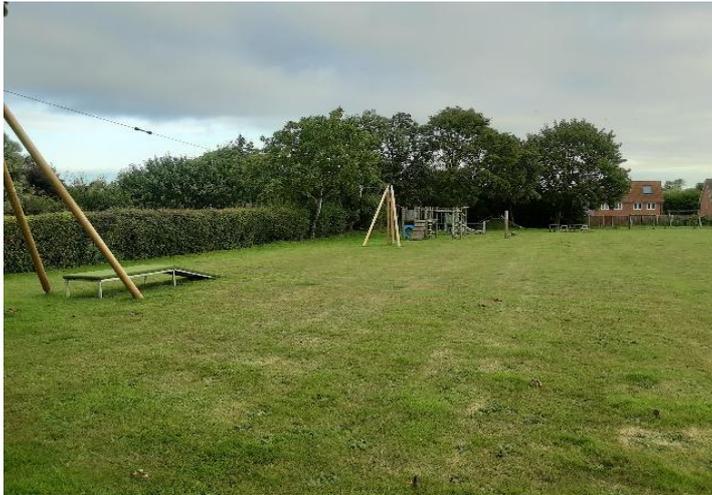
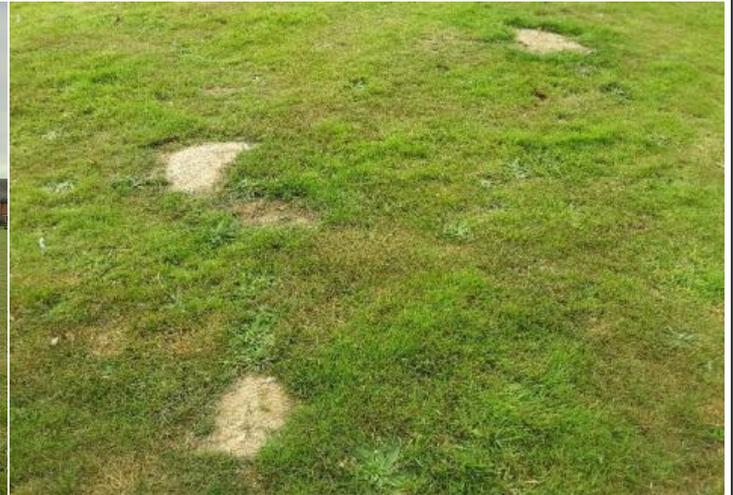
**Finding:** There are a number of molehills within the area and these may present unforeseen hazards for users

**Action:** Remove moles by appropriate means, reinstate surfaces to level and maintain the area

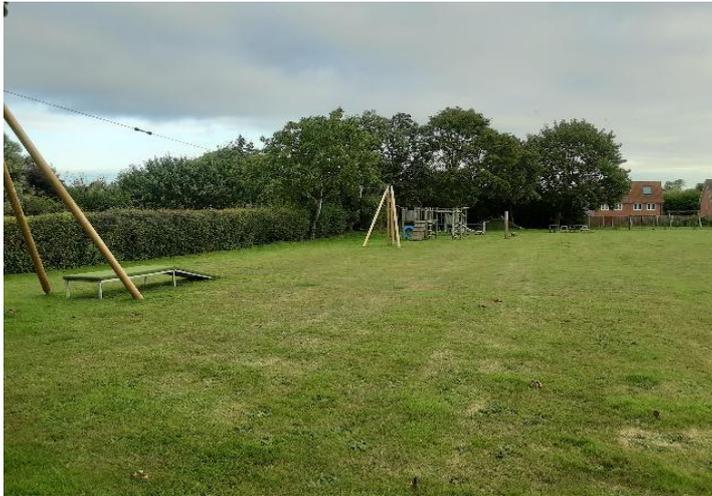
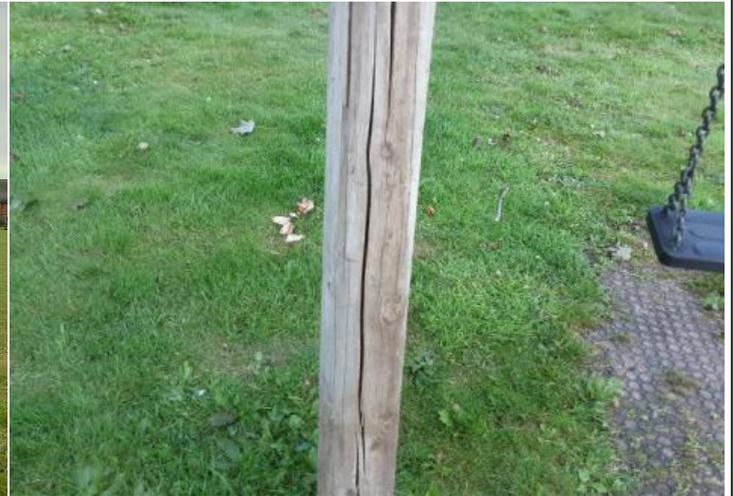
**Finding:** The timber has a number of splits/shakes or air cracks and this may affect the stability or allow water ingress which will accelerate the rotting process  
**Action:** Monitor to ensure the splits do not cross through fixing points of the structure and/or cause any instability

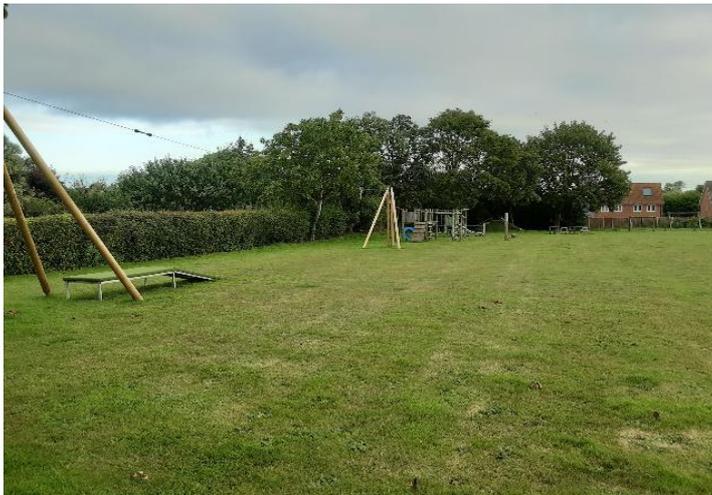
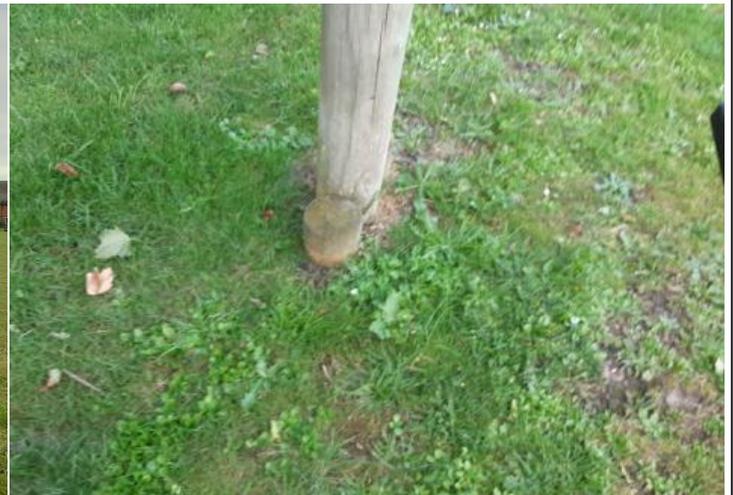
**Finding:** There is strimmer / machinery damage apparent on the posts, this can penetrate the preservative applied to the timber and accelerate the rotting process  
**Action:** Monitor for any deterioration (rot) and replace as required

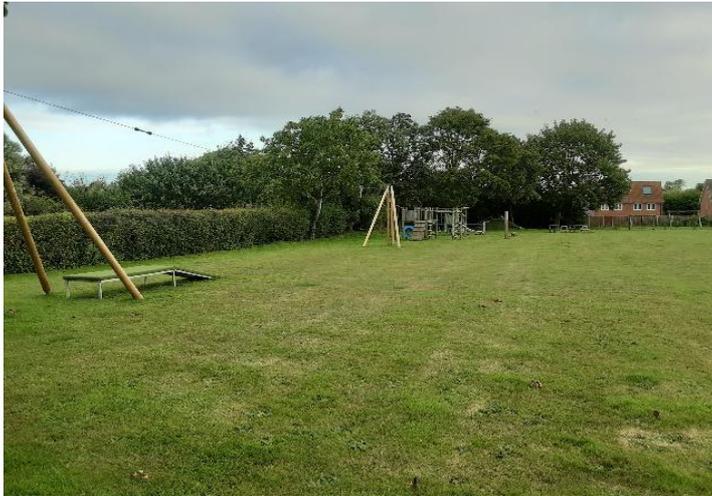
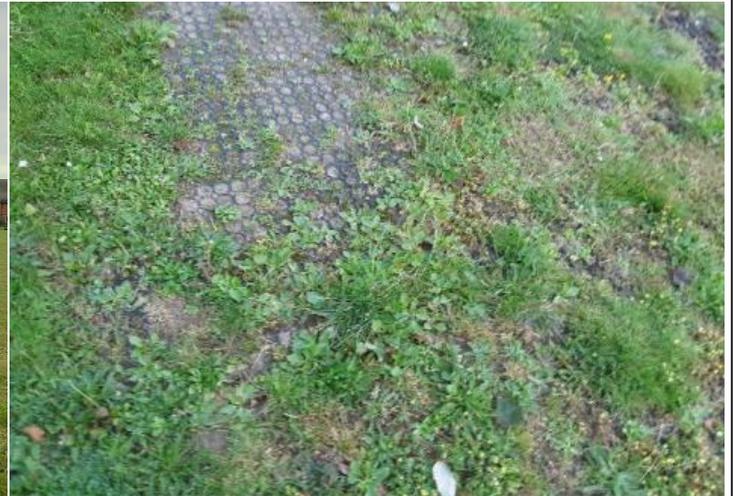
**Finding:** The grass mats are silted up and the soil is compacted; this may have an effect on the impact absorbing properties of the surface

**Action:** Consider HIC testing impact absorbing properties to ensure the correct surface qualities are maintained for the equipment and replace as required

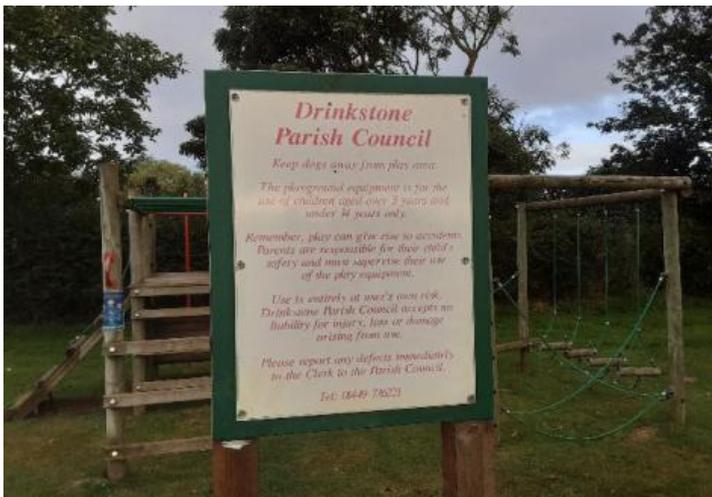
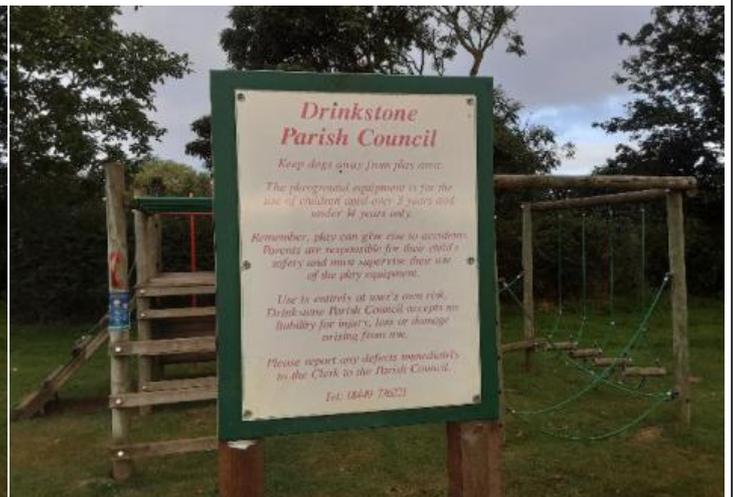
**Finding:** BS EN 1176 Part 7 recommends that signage shall include the site name / address

**Action:** Provide additional information

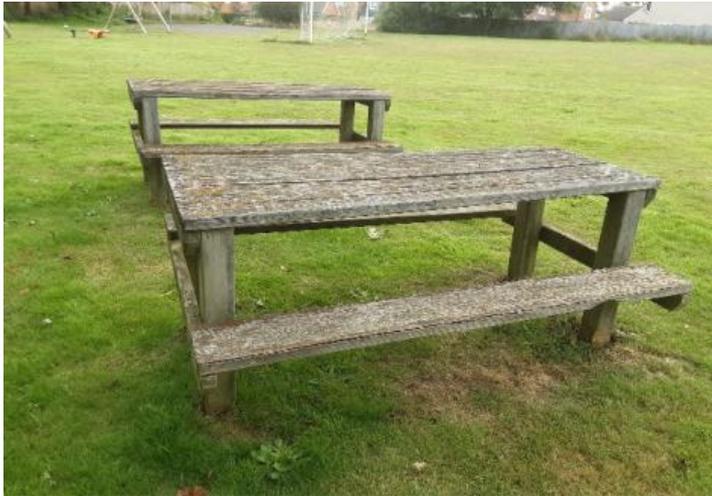
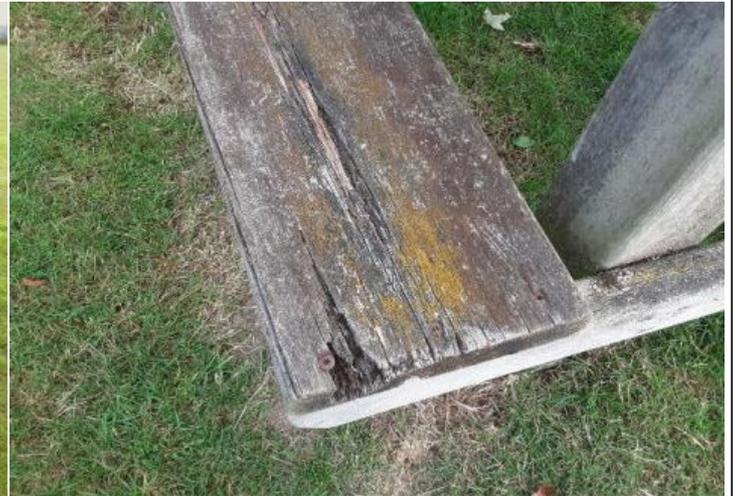
**Finding:** There is some evidence of rot in the timber

**Action:** Monitor for any further deterioration and replace as required

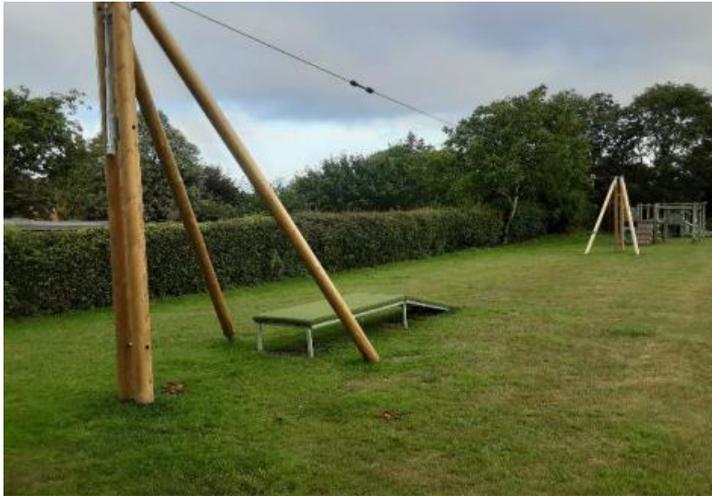
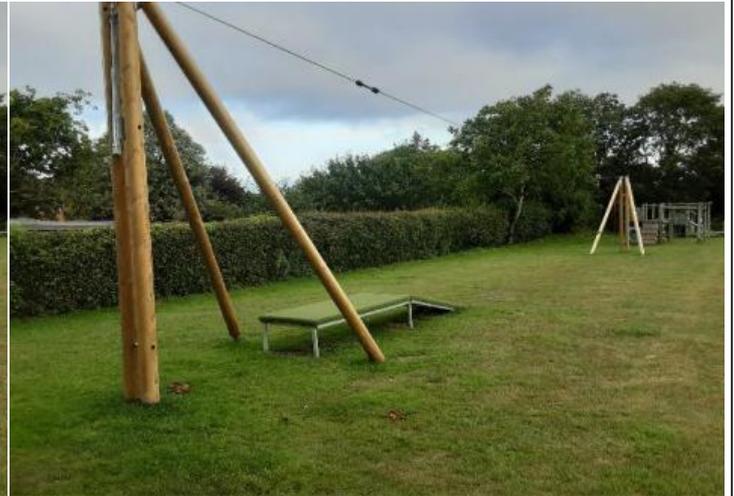
**Finding:** We have completed a visual inspection of the cable and fixing points from ground level, however it is not possible to fully inspect the cable and fixings without either hiring equipment to gain access or removing the cable and inspecting at ground level. We recommend that the main cable and fixing security is thoroughly inspected at least in accordance with the manufacturers recommendations to check for damage, security or internal rusting, this will help to ensure the continued safe use of the equipment

**Action:** Inspect in accordance with the manufacturers recommendations

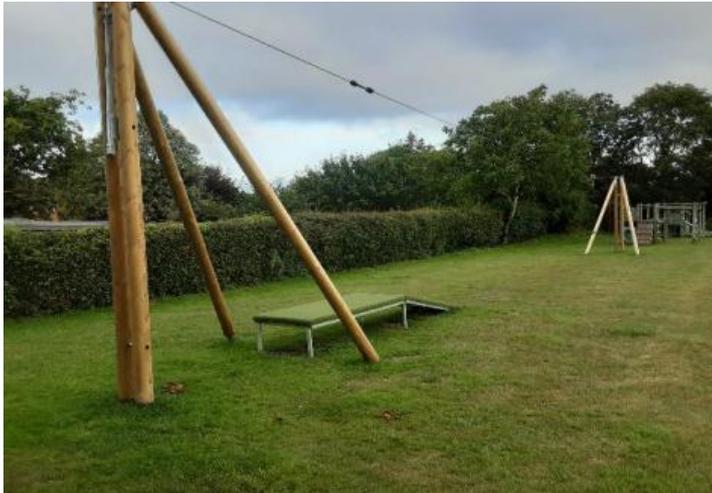
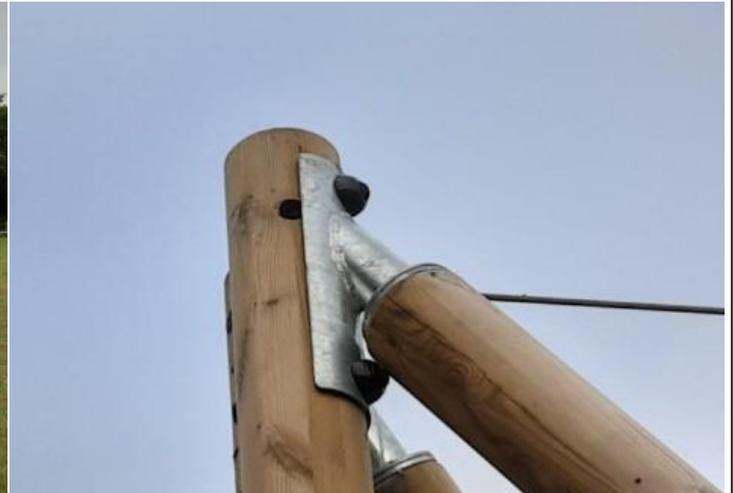
**Finding:** There is/are bolt cap covers missing or damaged on the item

**Action:** Replace missing or damaged bolt cap covers

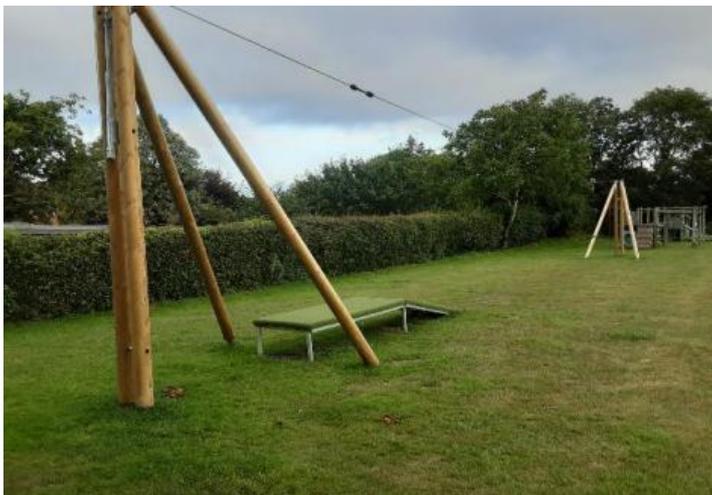
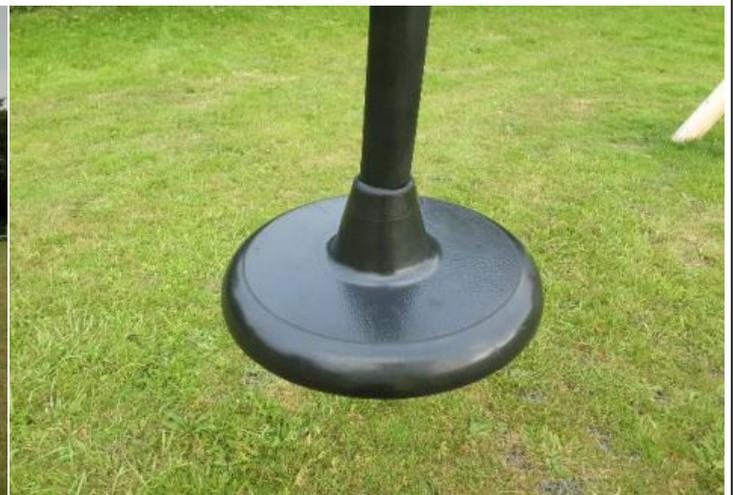
**Finding:** The seat connection cannot be inspected without dismantling the seat

**Action:** Dismantle the seat to inspect the seat connection for wear

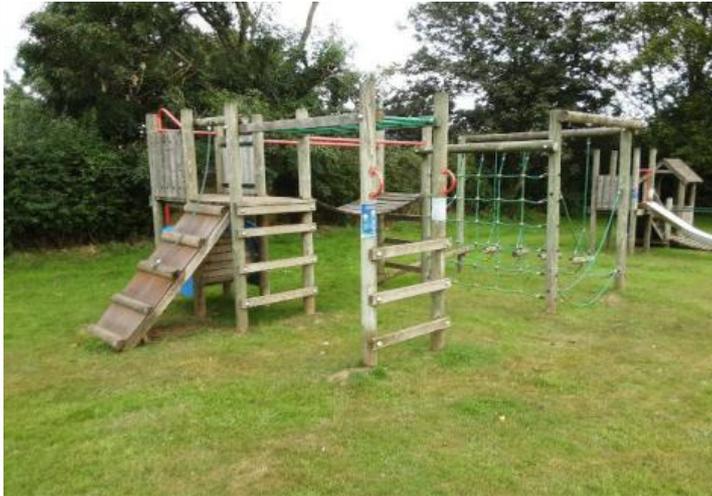
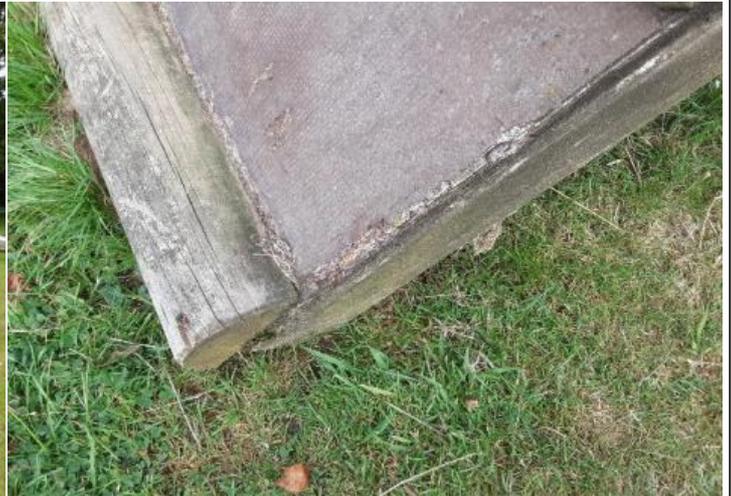
**Finding:** There is some evidence of rot in the timber

**Action:** Monitor for any further deterioration and replace as required

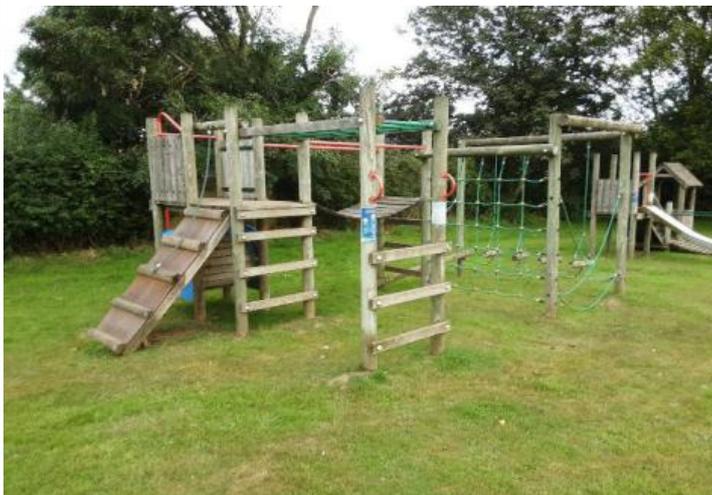
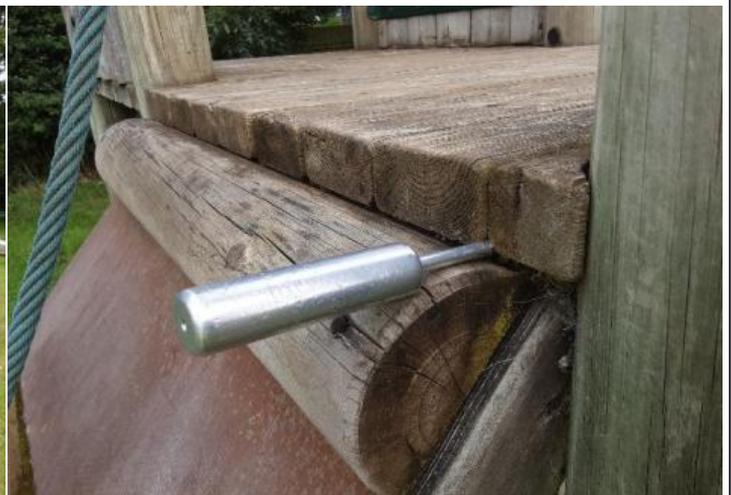
**Finding:** There is/are finger entrapment/s in the structure and the item fails to meet the requirements of BS EN 1176 Part 1 4.2.7.6 Entrapment of fingers

**Action:** Monitor - No remedial work recommended

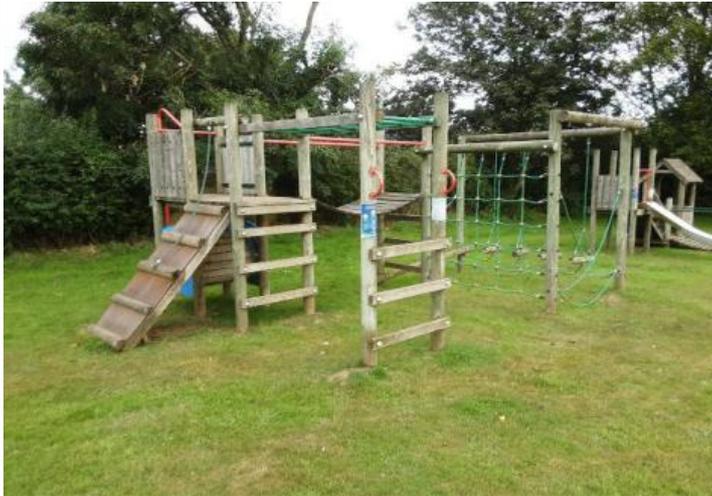
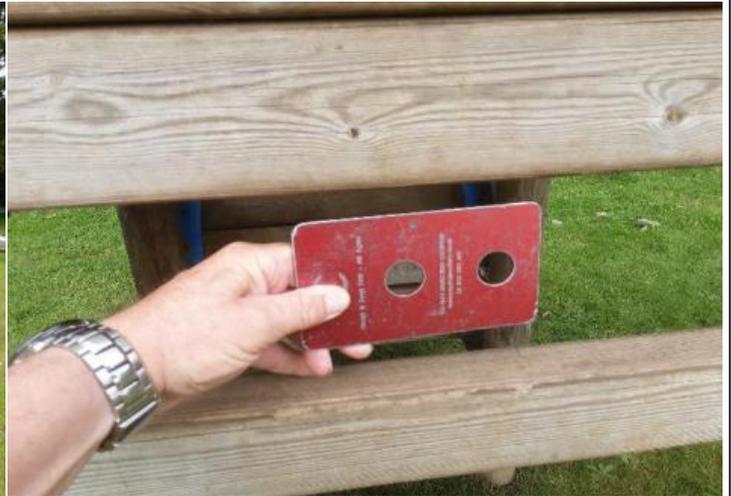
**Finding:** The item fails to meet the requirements of BS EN 1176 Part 1 4.2.7.2 for head and neck entrapment in the framework

**Action:** Monitor - No remedial work recommended

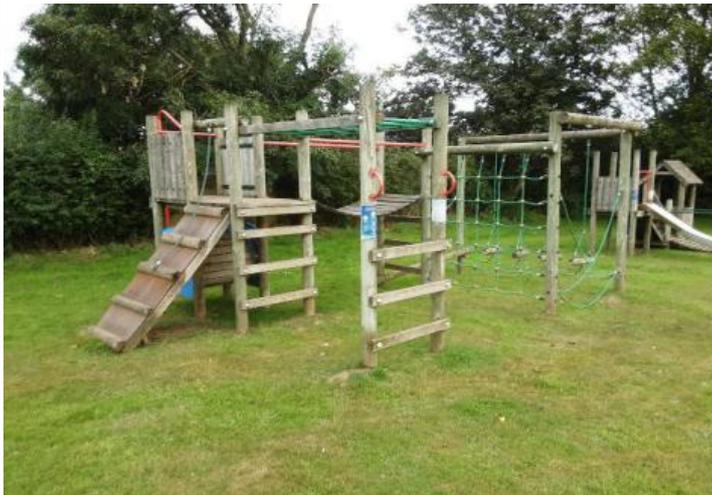
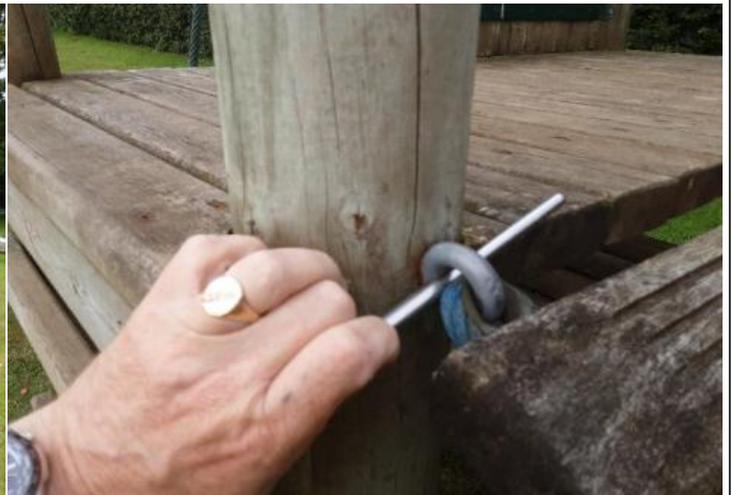
**Finding:** The connecting links are in excess of 8.6mm and less than 12mm and fail the requirements of BS EN 1176 Part 1; clause 4.2.13, Chains

**Action:** Monitor use and replace with compliant links at the next maintenance cycle

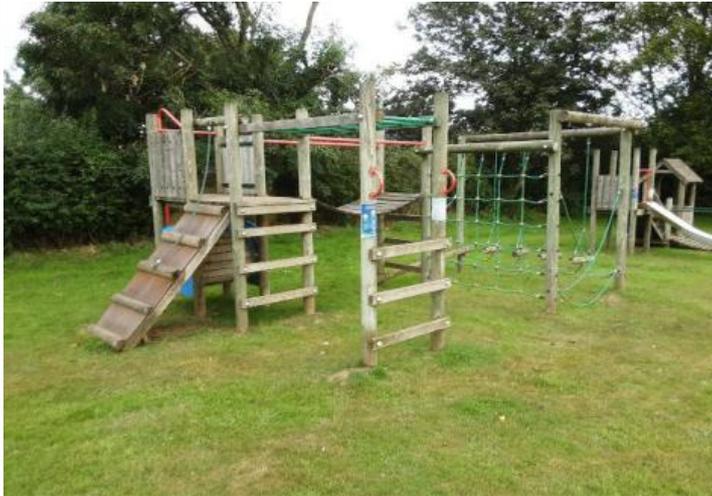
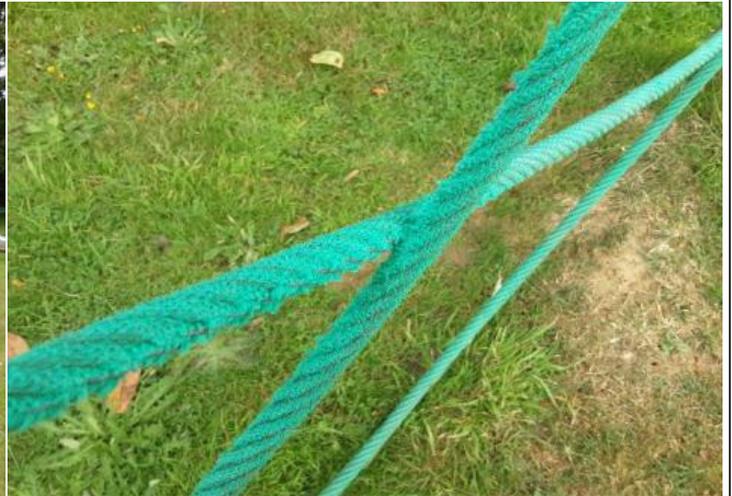
**Finding:** The ropes/nets are worn/damaged in places

**Action:** Monitor for any further deterioration and repair or replace as required

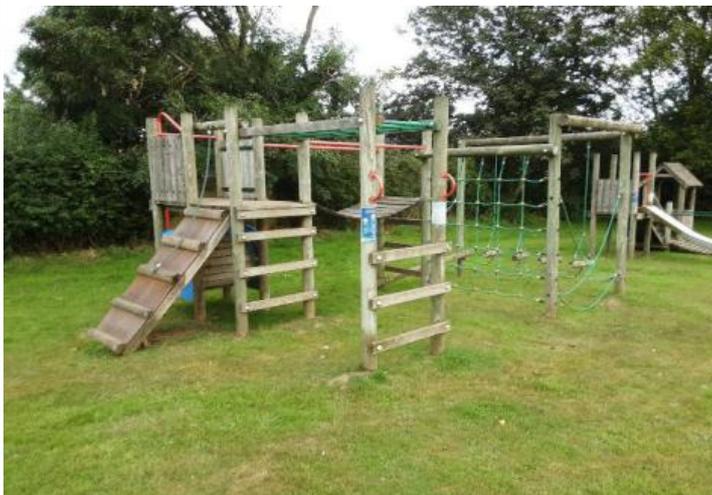
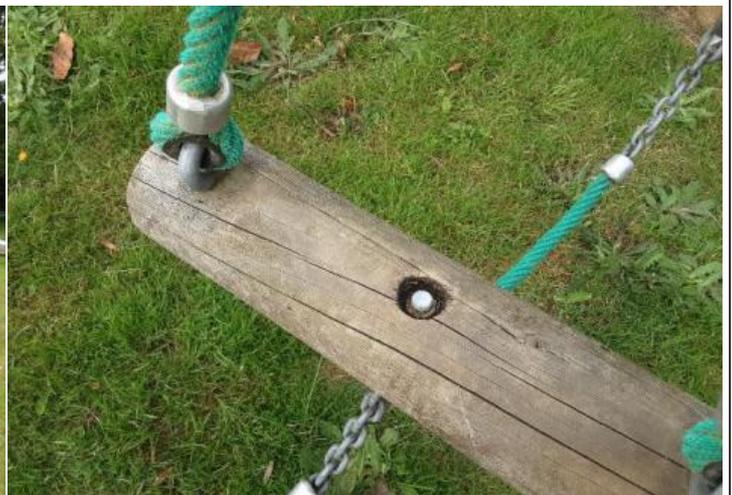
**Finding:** There is/are bolt cap covers missing or damaged on the item

**Action:** Replace missing or damaged bolt cap covers

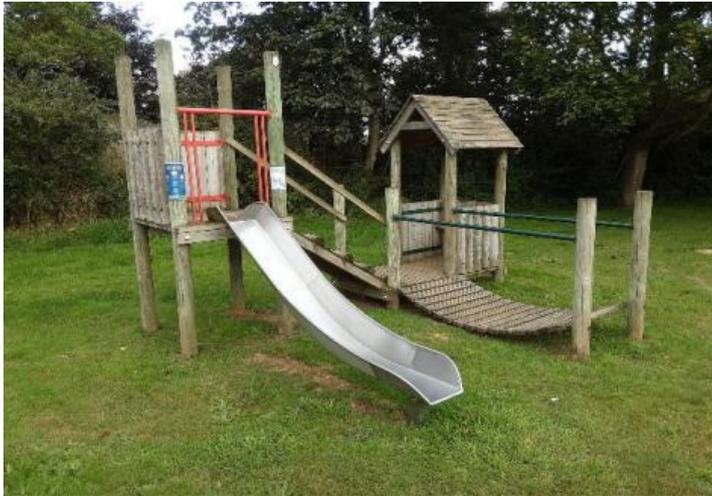
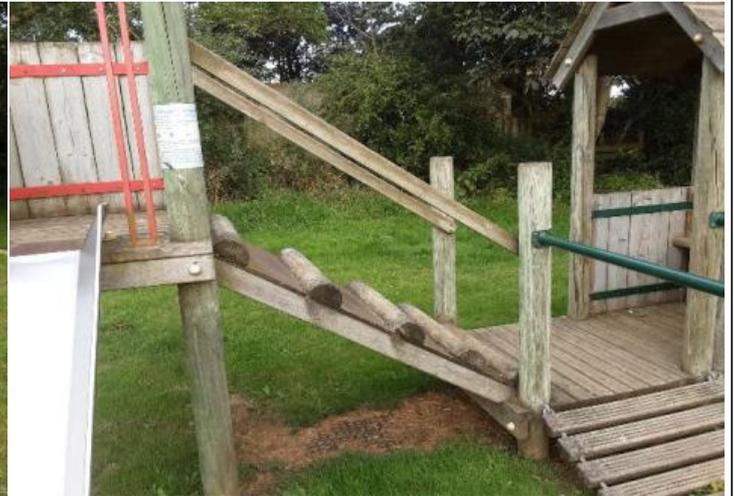
**Finding:** The unit is easily accessible and should have the appropriate barriers installed to meet the requirements of BS EN 1176 Part 1 as the height of the unit exceeds 600mm

**Action:** Monitor - No remedial work recommended

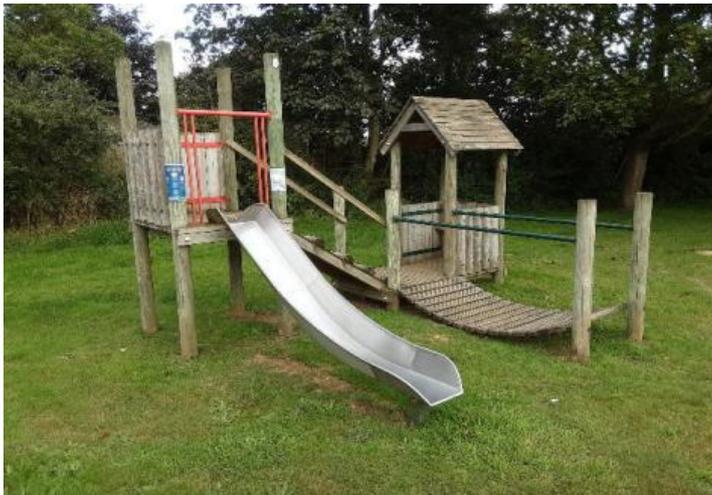
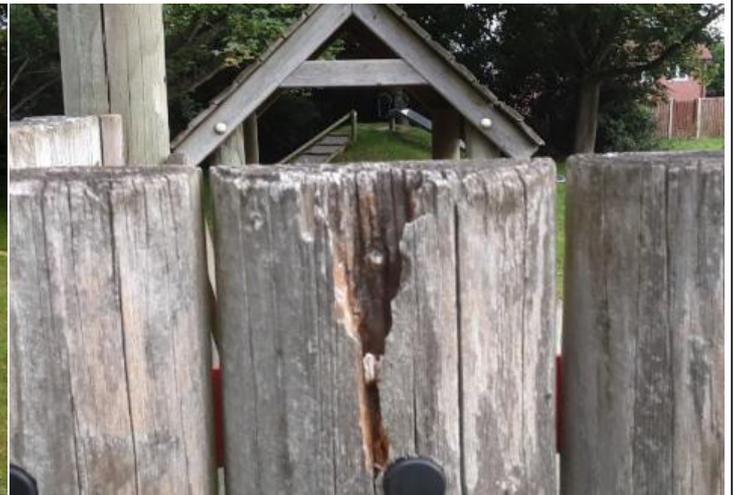
**Finding:** There are areas or parts of the timber on the structure that have rotted

**Action:** Replace all affected timbers

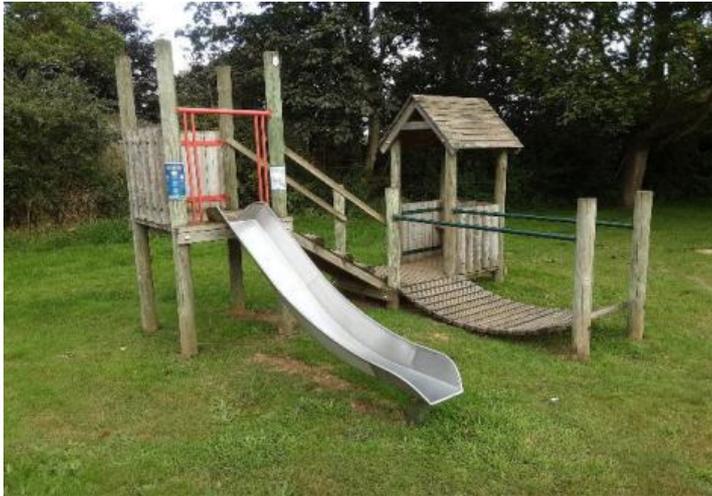
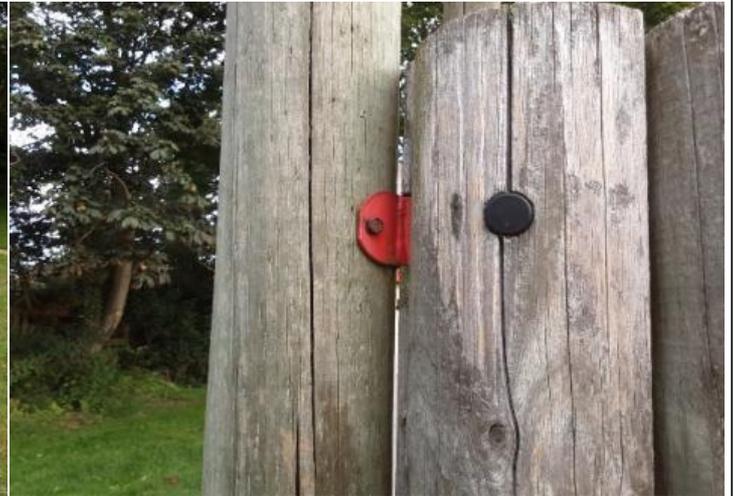
**Finding:** A number of fixing(s) have worked loose

**Action:** Secure all loose fixings

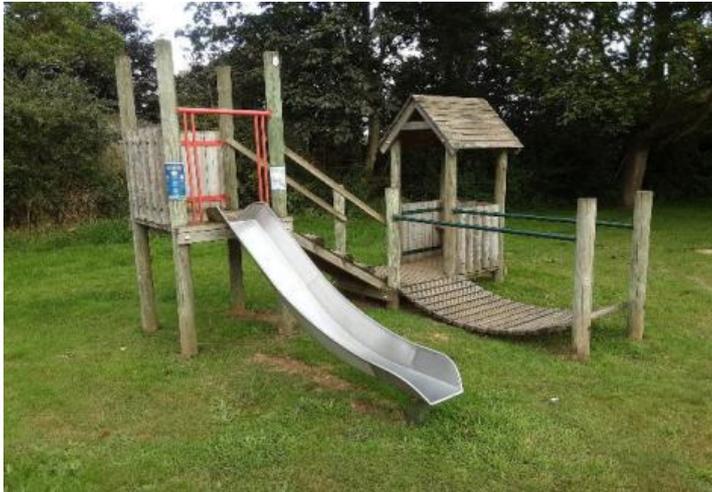
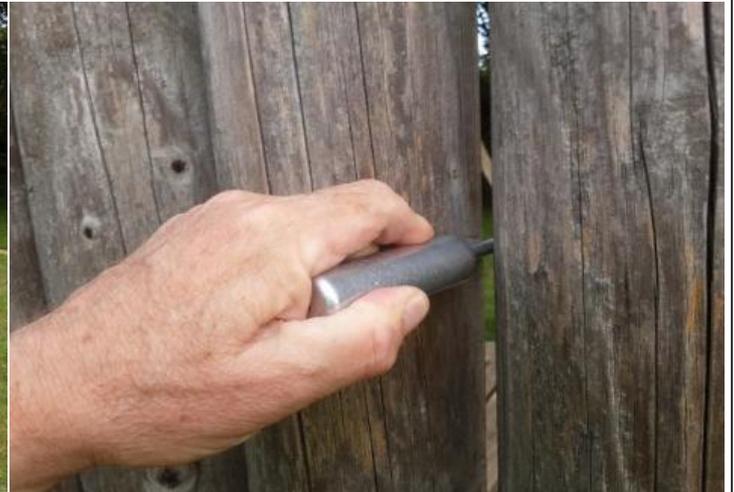
**Finding:** There is/are finger entrapment/s in the structure and the item fails to meet the requirements of BS EN 1176 Part 1 4.2.7.6 Entrapment of fingers

**Action:** Monitor - No remedial work recommended

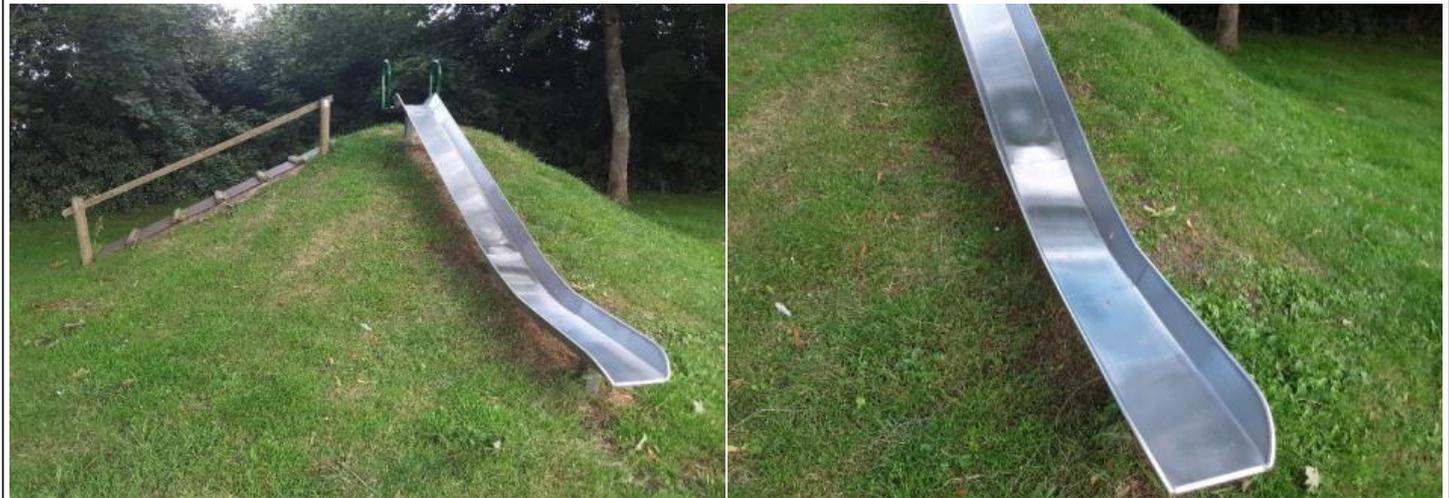
**Finding:** There are a number of dents in the slide surface  
**Action:** Monitor for any further deterioration and repair as required

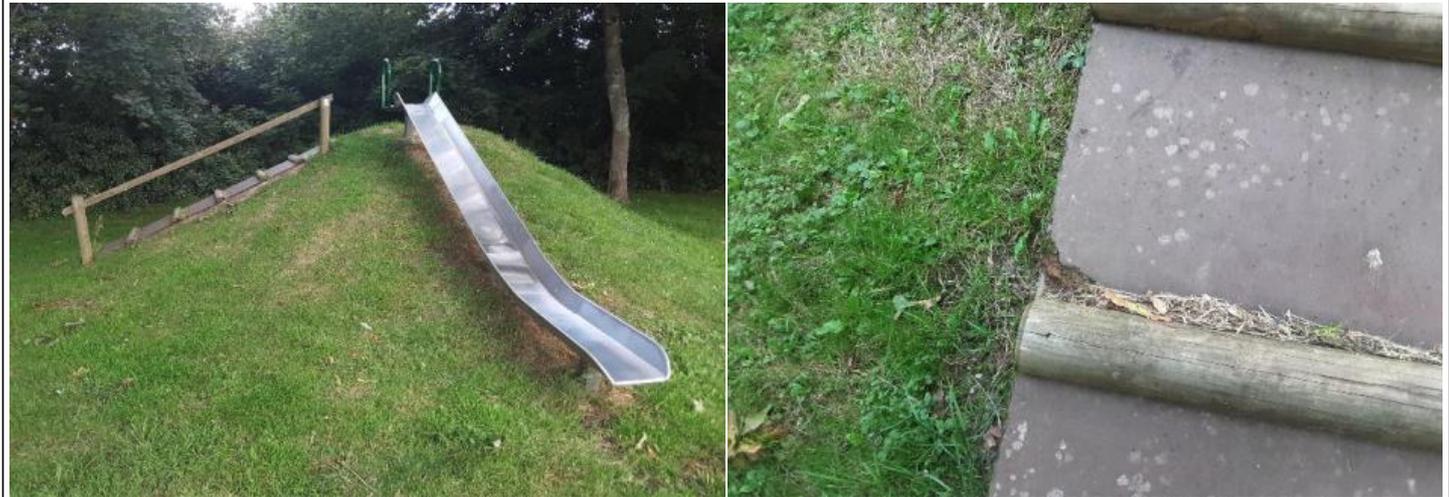
**Finding:** There are areas or parts of the timber access ramp that have rotted  
**Action:** Replace all affected timbers

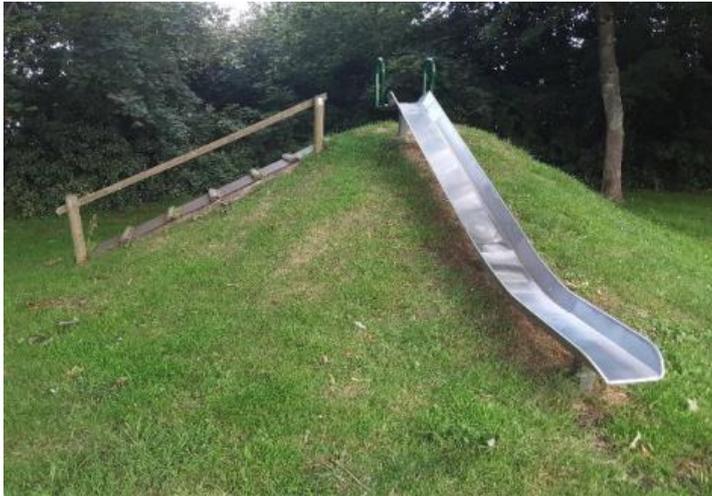
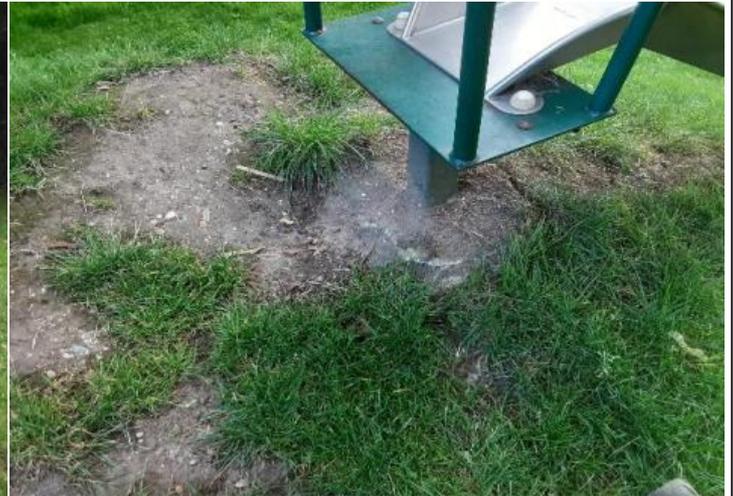
**Finding:** The surface has eroded and the foundations are exposed

**Action:** Reinstate surrounding surfaces to cover the foundations

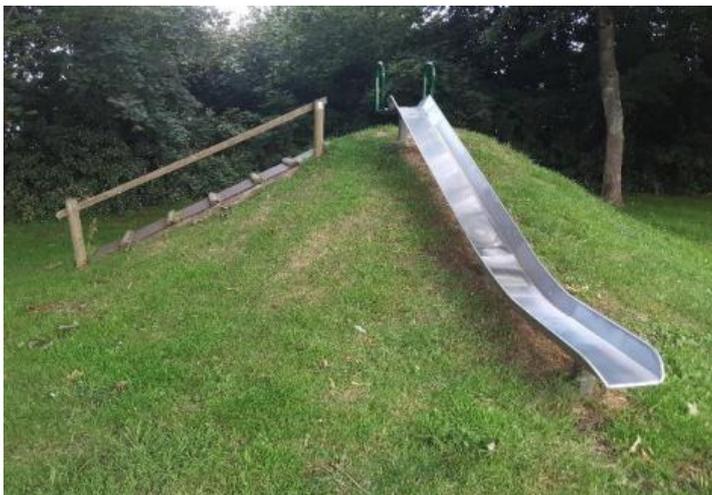
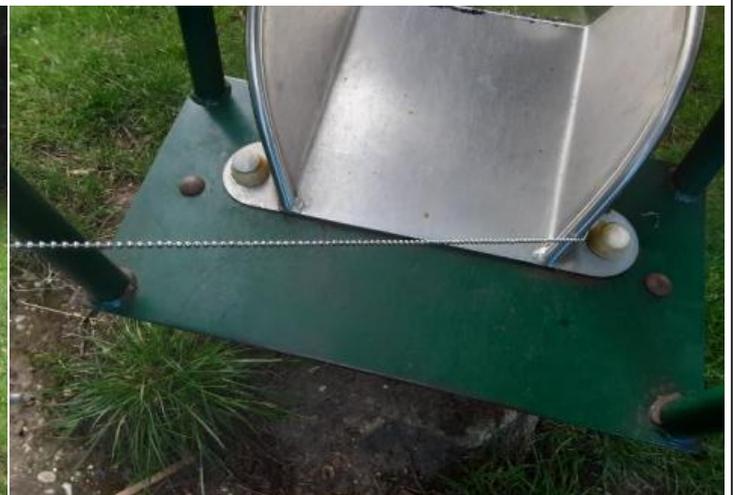
**Finding:** There is / are toggle entrapment/s present in contravention of the recommendations set out in BS EN 1176 Part 3

**Action:** Monitor - no remedial work recommended

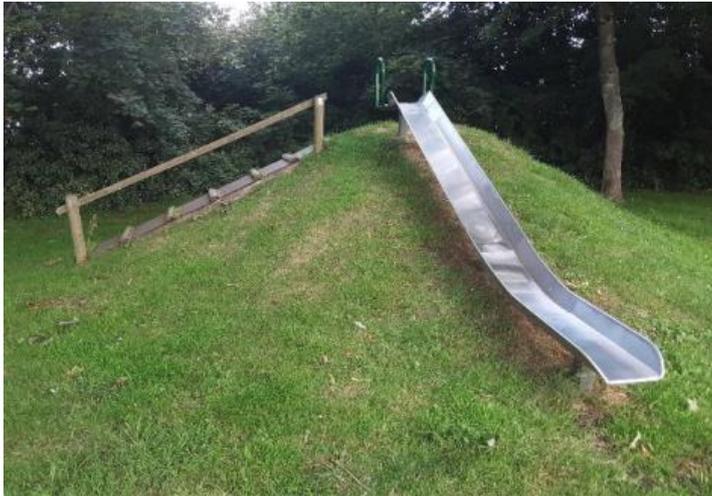
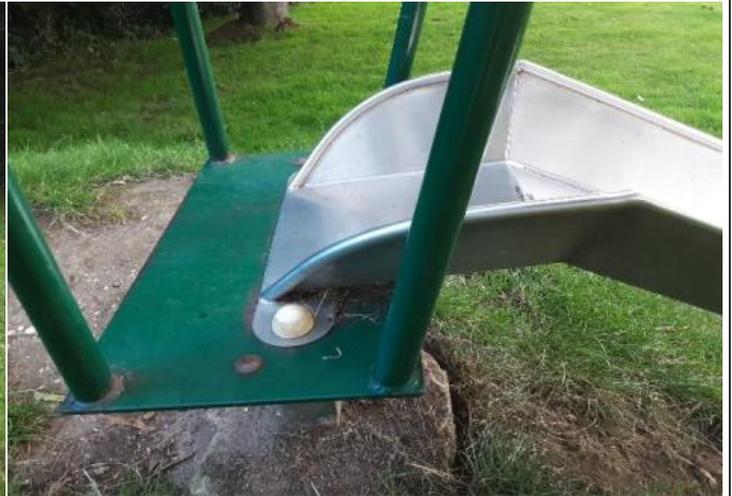
**Finding:** The slide start section incline is not in the direction of travel; it should slope towards the direction of the sliding surface to meet the requirements of BS EN 1176 Part 3

**Action:** Monitor - No remedial work recommended

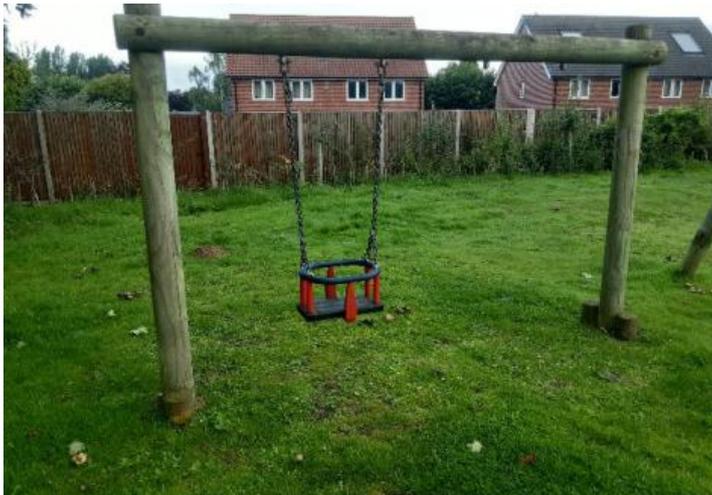
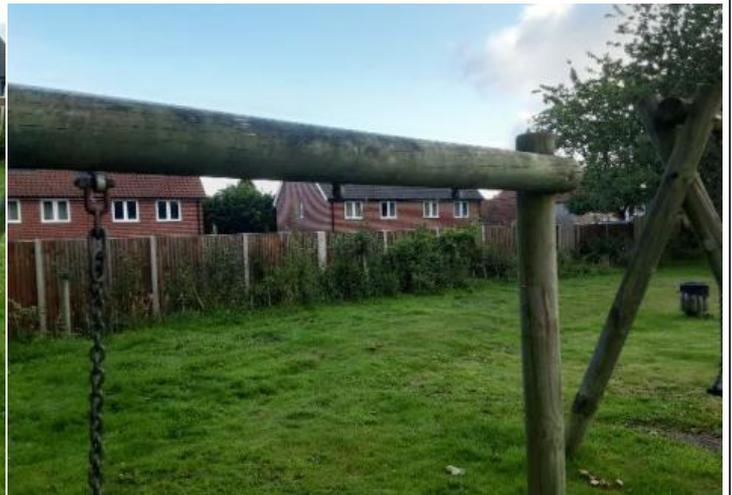
**Finding:** The item has missing component(s)

**Action:** Consider replacing missing components

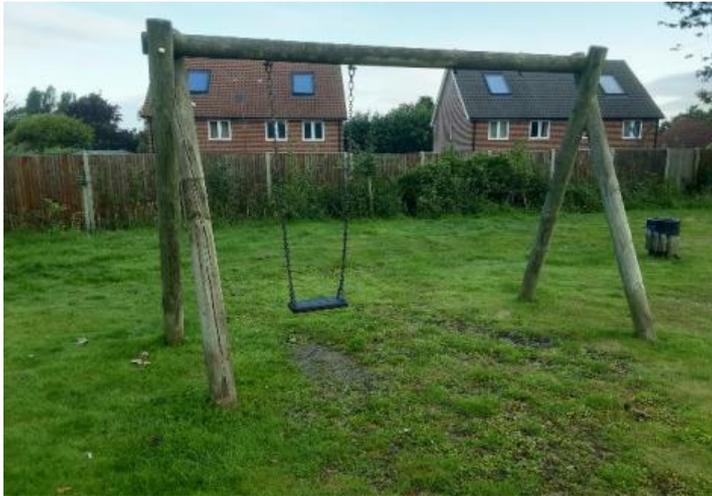
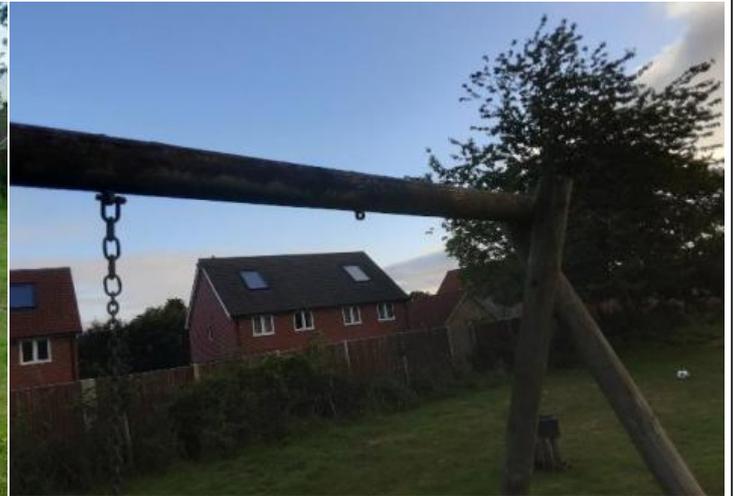
**Finding:** The item has missing component(s)

**Action:** Consider replacing missing components

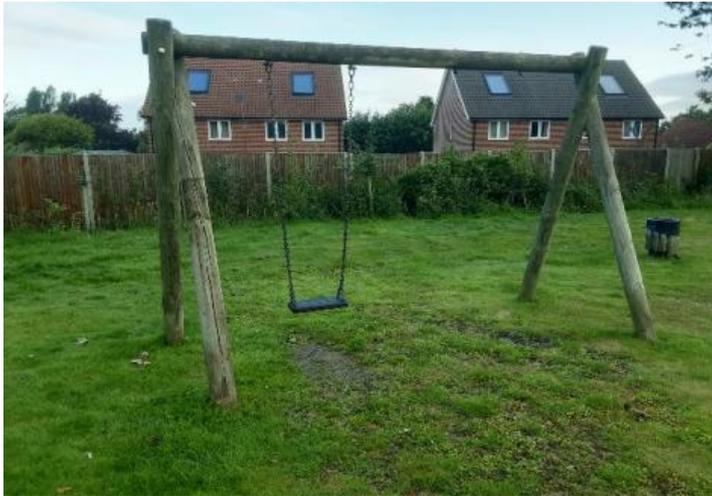
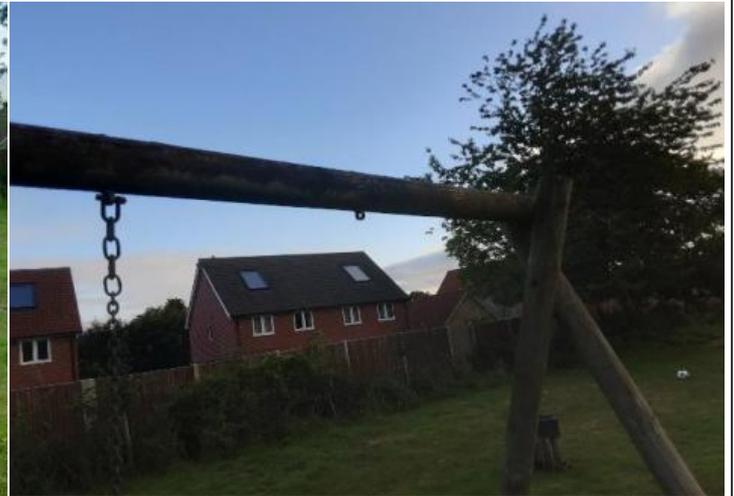
**Finding:** There is some wear to the shackles.

**Action:** Monitor for any further deterioration and replace when 40% worn

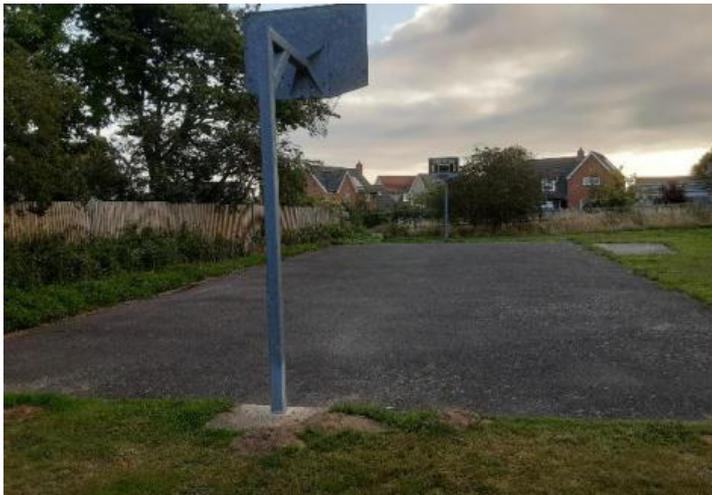
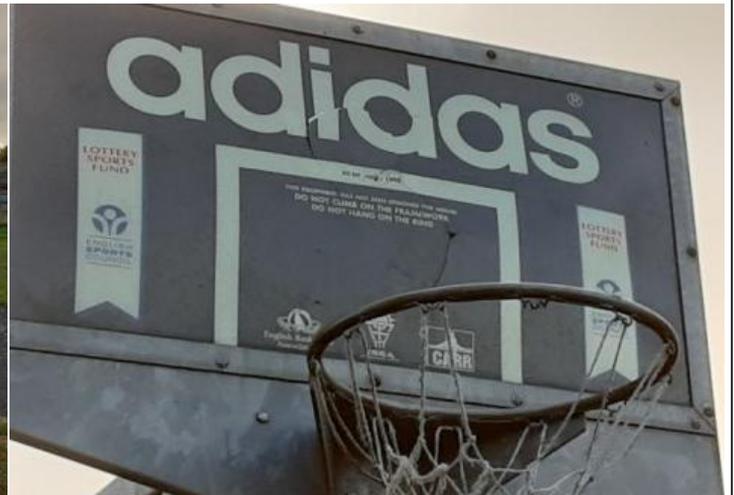
**Finding:** The backboard is damaged

**Action:** Monitor for any further deterioration and repair as required

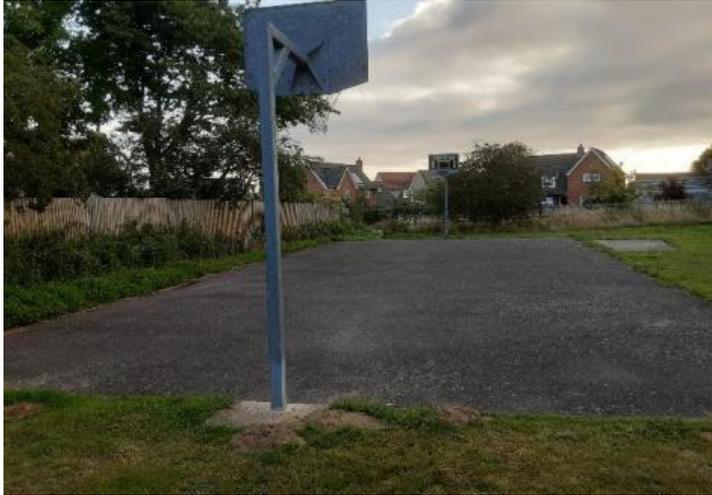
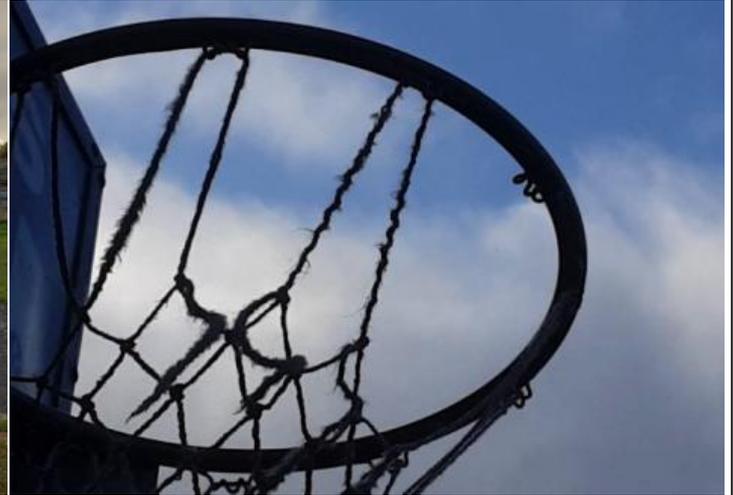
**Finding:** The hoop nets are damaged

**Action:** Replace the damaged hoop nets
