## Annual Inspection

Mid Suffolk District Council

Drinkstone

Annual Inspection - 03 August 2017 at 14:57 Inspector: Robert Baldock (RPII Annual Inspector)

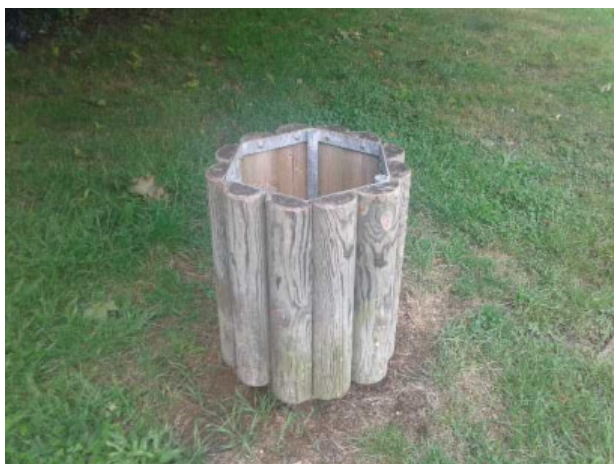
**Item:** Ancillary Items - Litter Bin  
**Manufacturer:** Owner/Operator  
**Surface Type:** N/A  
**Equipment Compliance:** N/A  
**Surface Area Compliance:** N/A  
**Ref/Part Number:**  
**Total Findings:** 1

There is no liner present in the litterbin - Provide as required

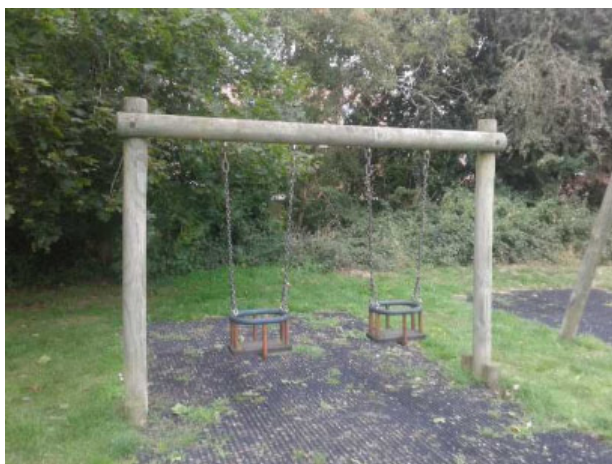
**Item:** Swings - 1 Bay 2 Seat (Cradle)  
**Manufacturer:** Adventure Playgrounds  
**Surface Type:** Grass Matrix Tiles  
**Equipment Compliance:** No  
**Surface Area Compliance:** Yes  
**Ref/Part Number:**  
**Total Findings:** 4

The tree canopy overhangs the equipment and is less than 2.0m away - Lift tree canopy to ensure a minimum clearance of 2.0m from the equipment

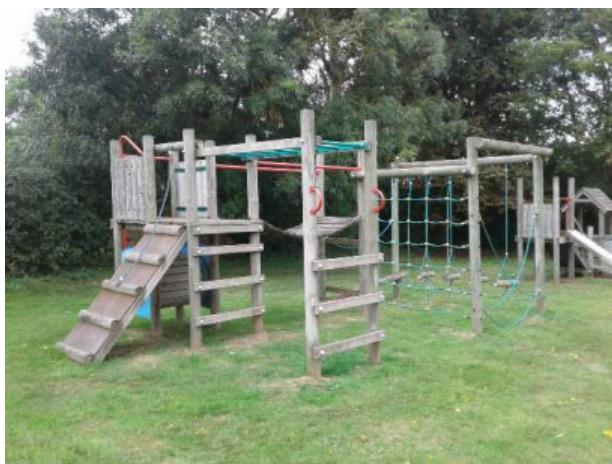
**Item:** Activity Equipment - Log Climber  
**Manufacturer:** Adventure Playgrounds  
**Surface Type:** Grass Matrix Tiles  
**Equipment Compliance:** No  
**Surface Area Compliance:** Yes  
**Ref/Part Number:**  
**Total Findings:** 10

There are falls in excess of 600mm between adjacent components on the structure - Monitor use

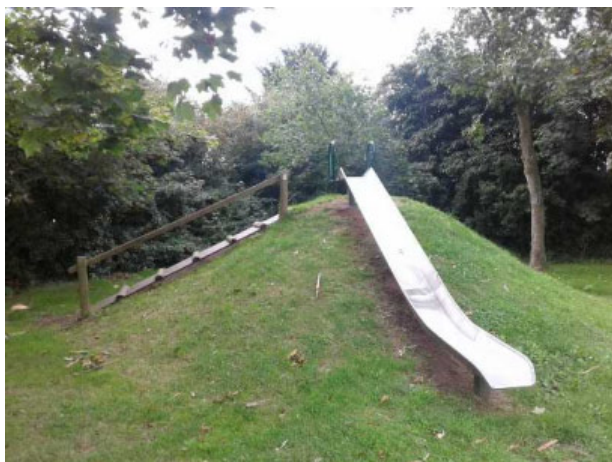
**Item:** Activity Equipment - Multi Play (Junior)  
**Manufacturer:** Owner/Operator  
**Surface Type:** Grass  
**Equipment Compliance:** No  
**Surface Area Compliance:** Yes  
**Ref/Part Number:**  
**Total Findings:** 4

The surface has eroded in some areas - Reinststate the surface
