## Annual Inspection

Mid Suffolk District Council

Drinkstone

Inspected: 12-August-2021 - 06:00 by Lyn Williams RPII Annual Inspector

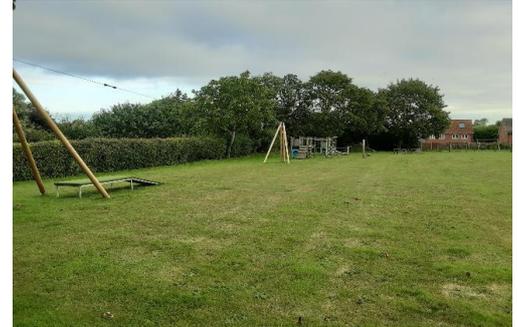
**Item:** Site General  
**Manufacturer:** Not Applicable  
**Surface Type:** N/A  
**Item Quantity:** 1  
**Equipment Compliance:** N/A  
**Surface Area Compliance:** N/A

There are a number of molehills within the area and these may present unforeseen hazards for users - Remove moles by appropriate means, reinstate surfaces to level and maintain the area

The timber has a number of splits/shakes or air cracks and this may affect the stability or allow water ingress which will accelerate the rotting process - Monitor to ensure the splits do not cross through fixing points of the structure and/or cause any instability

There is strimmer / machinery damage apparent on the posts, this can penetrate the preservative applied to the timber and accelerate the rotting process - Monitor for any deterioration (rot) and replace as required

The grass mats are silted up and the soil is compacted; this may have an effect on the impact absorbing properties of the surface - Consider HIC testing impact absorbing properties to ensure the correct surface qualities are maintained for the equipment and replace as required

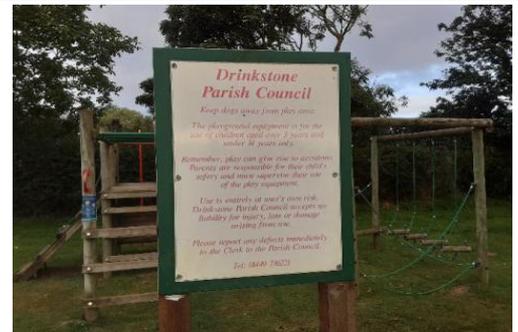
**Item:** Sign  
**Manufacturer:** Owner/Operator  
**Surface Type:** N/A  
**Item Quantity:** 1  
**Equipment Compliance:** N/A  
**Surface Area Compliance:** N/A

BS EN 1176 Part 7 recommends that signage shall include the site name / address - Provide additional information

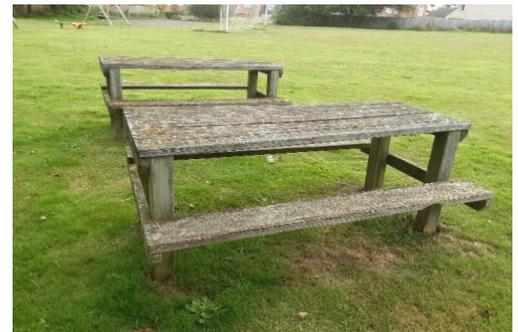
**Item:** Picnic Table  
**Manufacturer:** Owner/Operator  
**Surface Type:** N/A  
**Item Part Number:**  
**Item Quantity:** 2  
**Equipment Compliance:** N/A  
**Surface Area Compliance:** N/A  
**Total Findings:** 1

There is some evidence of rot in the timber - Monitor for any further deterioration and replace as required

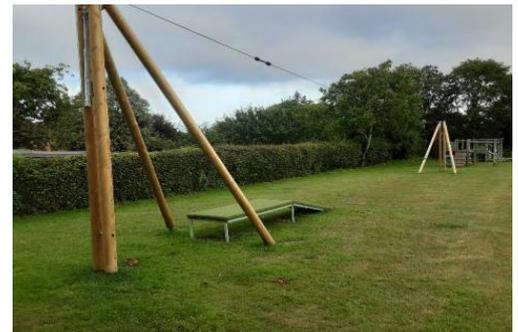
**Item:** Cable Runway  
**Manufacturer:** Playdale Playgrounds Ltd  
**Surface Type:** Grass Matrix Tiles  
**Item Quantity:** 1  
**Equipment Compliance:** Yes  
**Surface Area Compliance:** Yes

We have completed a visual inspection of the cable and fixing points from ground level, however it is not possible to fully inspect the cable and fixings without either hiring equipment to gain access or removing the cable and inspecting at ground level. We recommend that the main cable and fixing security is thoroughly inspected at least in accordance with the manufacturers recommendations to check for damage, security or internal rusting, this will help to ensure the continued safe use of the equipment - Inspect in accordance with the manufacturers recommendations
